**SHORELINE CHANGE ANALYSIS OF THE VIZHINJAM COAST
USING BEACH PROFILES AND SATELLITE IMAGES**

ANNUAL REPORT

(October 2024 to September 2025)

**Coastal and Environmental Engineering Division
NATIONAL INSTITUTE OF OCEAN TECHNOLOGY**

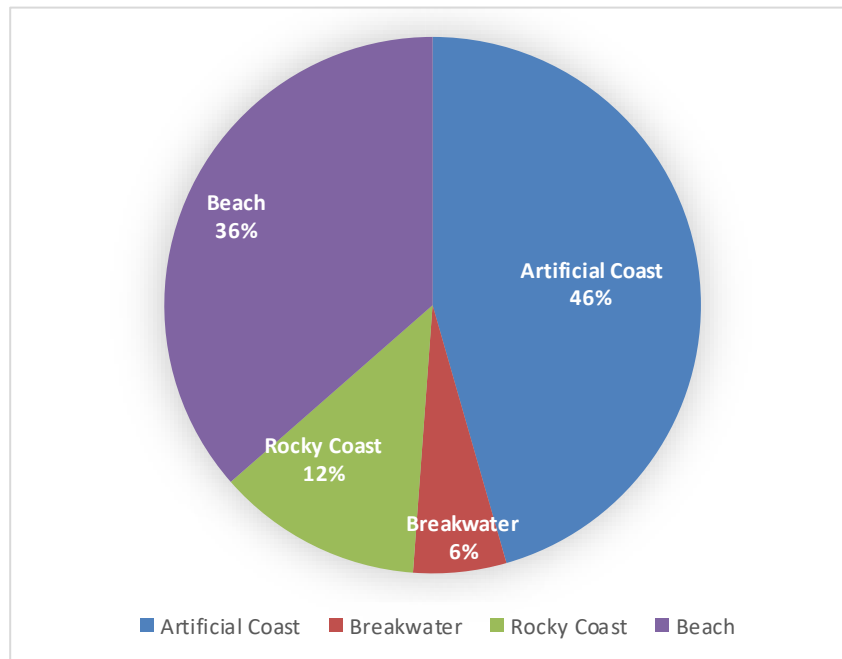
Figure 3.1 Location map depicting the coastal structures along the study area

The artificially modified coastline includes a 13 km-long seawall extending north of the port, with approximately 7.3 km reported as damaged (data sourced from the Kerala Irrigation Department) due to intense wave activity. Additionally, 29 groynes were constructed between 2020 and 2024, with two more groynes added in 2025 along the southern stretch of the Vizhinjam coast, extending into Tamil Nadu. The timeline of climatic and Port (Dredging and Reclamation activity and Breakwater construction) events along the Vizhinjam Coast is shown in Figure 3.3. Between October 2024 and September 2025, no dredging or breakwater construction took place in the Port area. Table 3.2 lists the natural and Port events from 2015 and the corresponding wave data from the Wave Rider Buoy. Cyclones Ockhi (December 2017) and Tauktae (May 2021), recurrent swell surges (Kallakadal), and enhanced monsoon activity have exerted significant impacts on the morphology of the Vizhinjam coast.

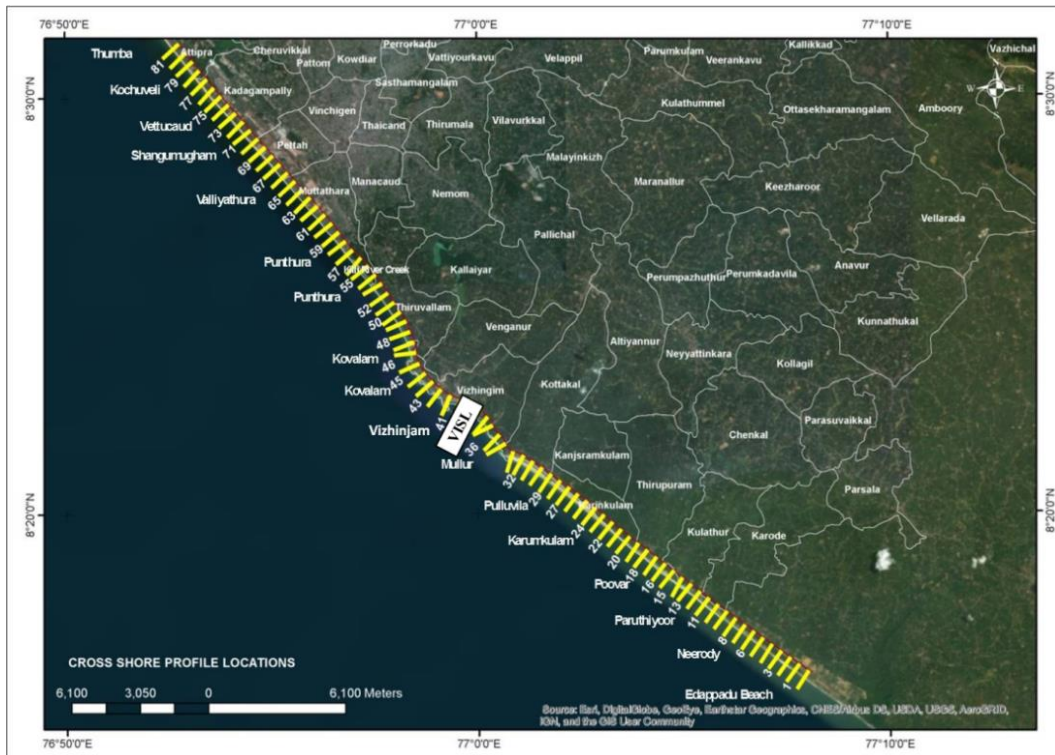
Figure 4.1 Cross-Shore Profiles lines on either side of the Vizhinjam Port

Shoreline Change analysis using Cross Shore Profile (CSP) has been done as part of the Shoreline Monitoring Programme. CSP data is being collected monthly by the surveying agency engaged by AVPPL every month at 81 profile lines along a stretch of 40 km (from February 2015 to till date). The locations of the CSP lines are shown in Figure 4.1, and the corresponding landmarks and location names are given in Table 4.2.

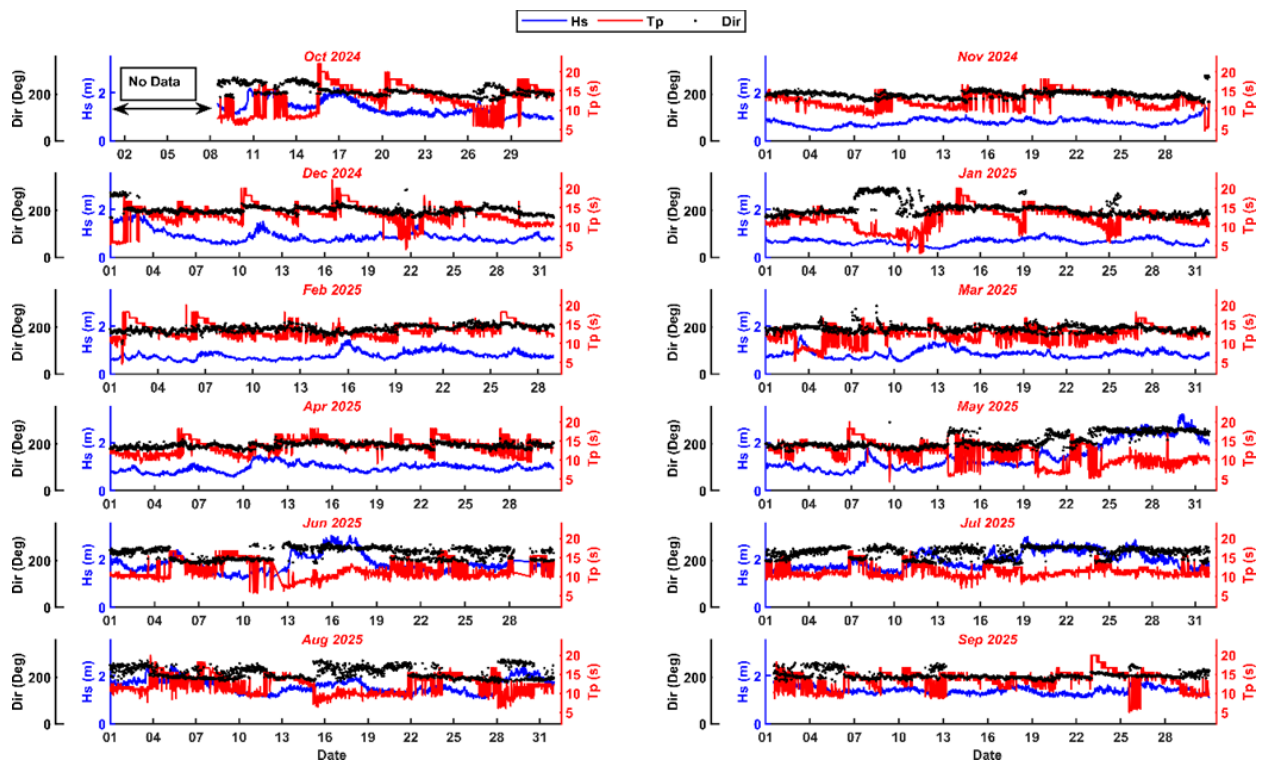
Figure 4.8 Wave observation from October 2024 to September 2025.

October 1, 2024, to September 30, 2025. There is a data gap from October 1, 2024, to October 8, 2024. During the fair-weather season, the sea state remains relatively calm, with an average Hs of 0.79 m. The maximum Hs of 1.87 m was observed on December 2, 2024. In contrast, the Hs during the monsoon seasons is higher, with an average of 1.67 m and a maximum of 2.98 m reported on June 15, 2025. The pre-monsoon season is characterized by moderate sea conditions, with an average Hs of 1.19 m, but the maximum of 3.18 m was observed on 30th May, 2025, due to a tropical disturbance designated as Invest 93A formed in the Arabian Sea near the west coast of India. The minimum Hs observed during the study period was 0.35 m on 8th January, 2025. The average Tp remains consistent around 12 seconds, with maximum Tp ranging from 20.00 s to 22.22 s during different seasons. Pre-monsoon season experiences long-period waves with a Tp of 22.22 s, followed by the monsoon season. The minimum Tp ranges between 3.03 s (during the Fair-weather season) and 5.0 s (during the monsoon season).

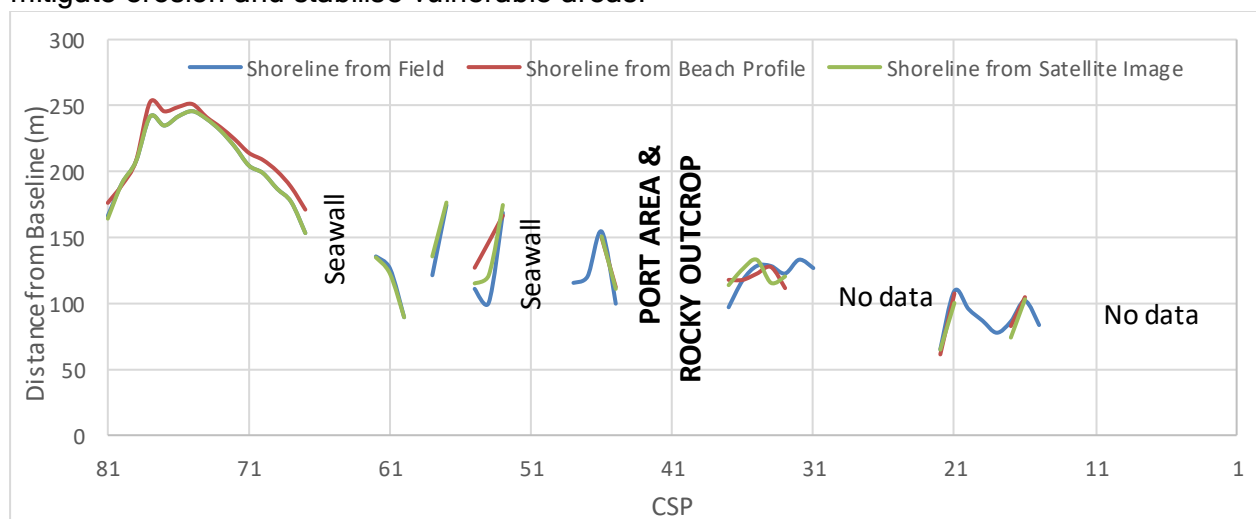
Figure 5.5 Comparison of shoreline changes estimated from the satellite images, beach profiles and field data at 500m intervals.

Key findings indicate zones of high erosion predominantly at Valliyathura, Shangumugham, Punthura, Poovar, and Edapadu. Historical records (Table 5.4) show erosion hotspots at Valliyathura and Punthura during different periods, with consistent vulnerability observed. In contrast, areas such as Poovar, Vizhinjam Port region, Adimalathura, Karumkulam, and Kochuthura were identified as high accretion zones, indicating sediment deposition and shoreline growth. These studies highlight the dynamic nature of the Thiruvananthapuram coast, underscoring the need for ongoing monitoring and targeted coastal management strategies to mitigate erosion and stabilise vulnerable areas.

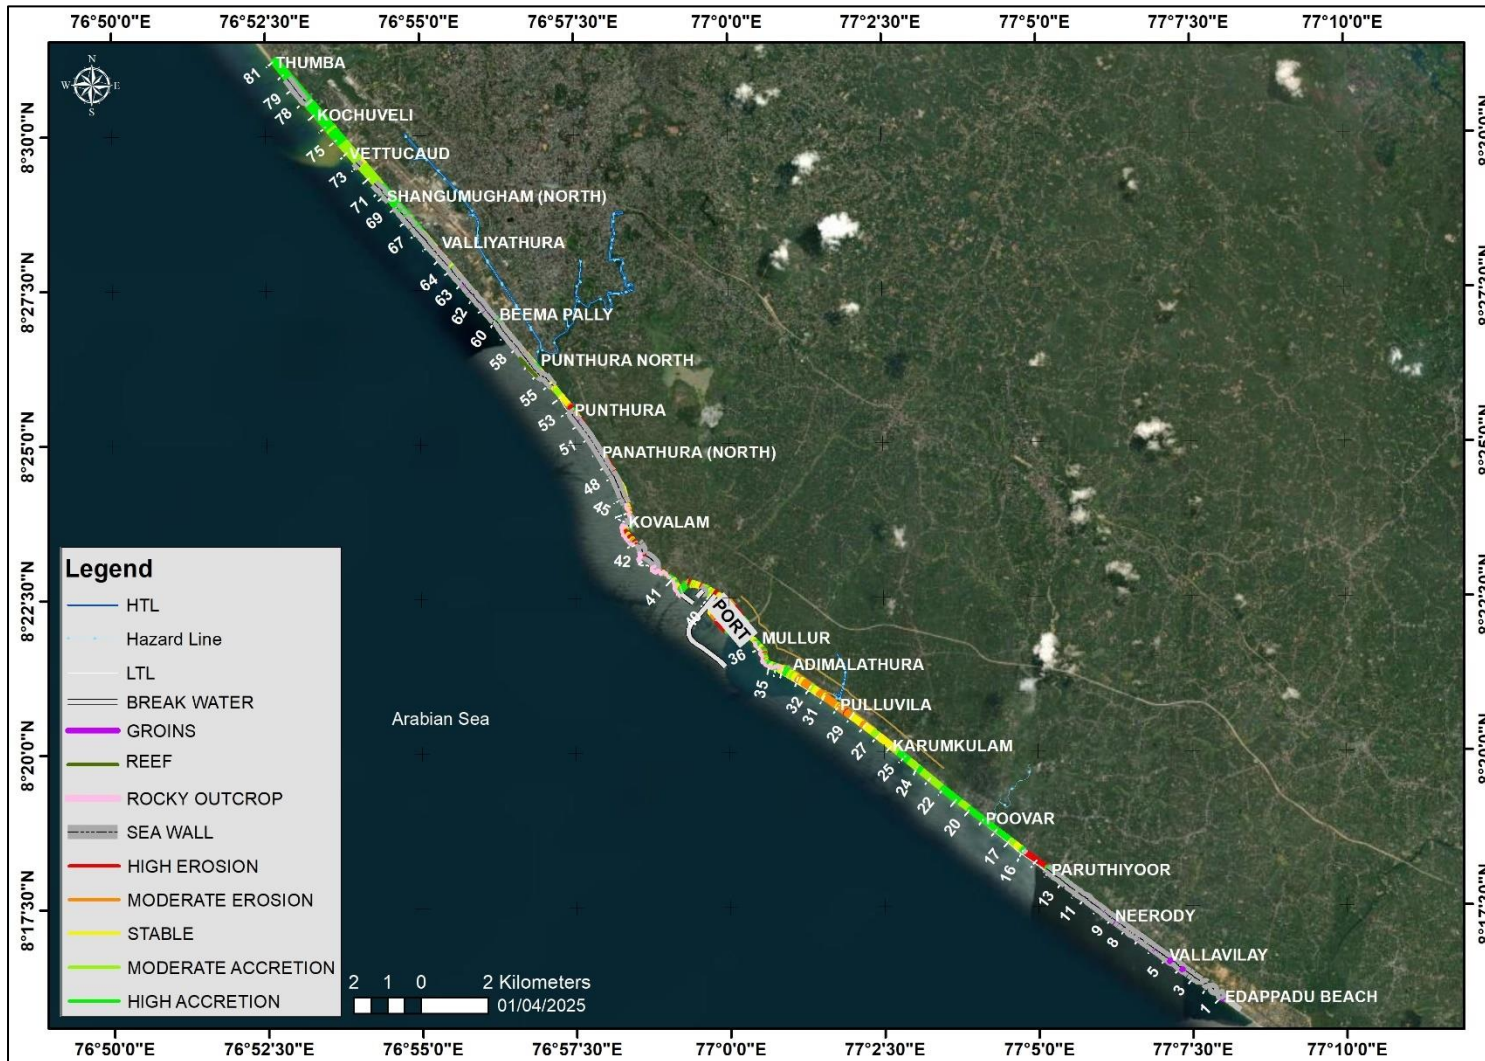
The monthly shoreline change analysis for April 2025 indicates erosion at Paruthiyoor (CSP14-16), Puuluvia to Adimalathura (CSP28-33), Kovalam (CSP43-44), Pannathura (CSP47-53), Valliyathura (CSP63-65), while accretion at Edapadu to Paruthiyoor (CSP01-13), Poovar (CSP16-27), Kovalam (CSP40-42), Pannathura (CSP45-46), Punthura (CSP54-57), Beemapally (CSP58-62), Valliyathura to Thumba (CSP66-81).

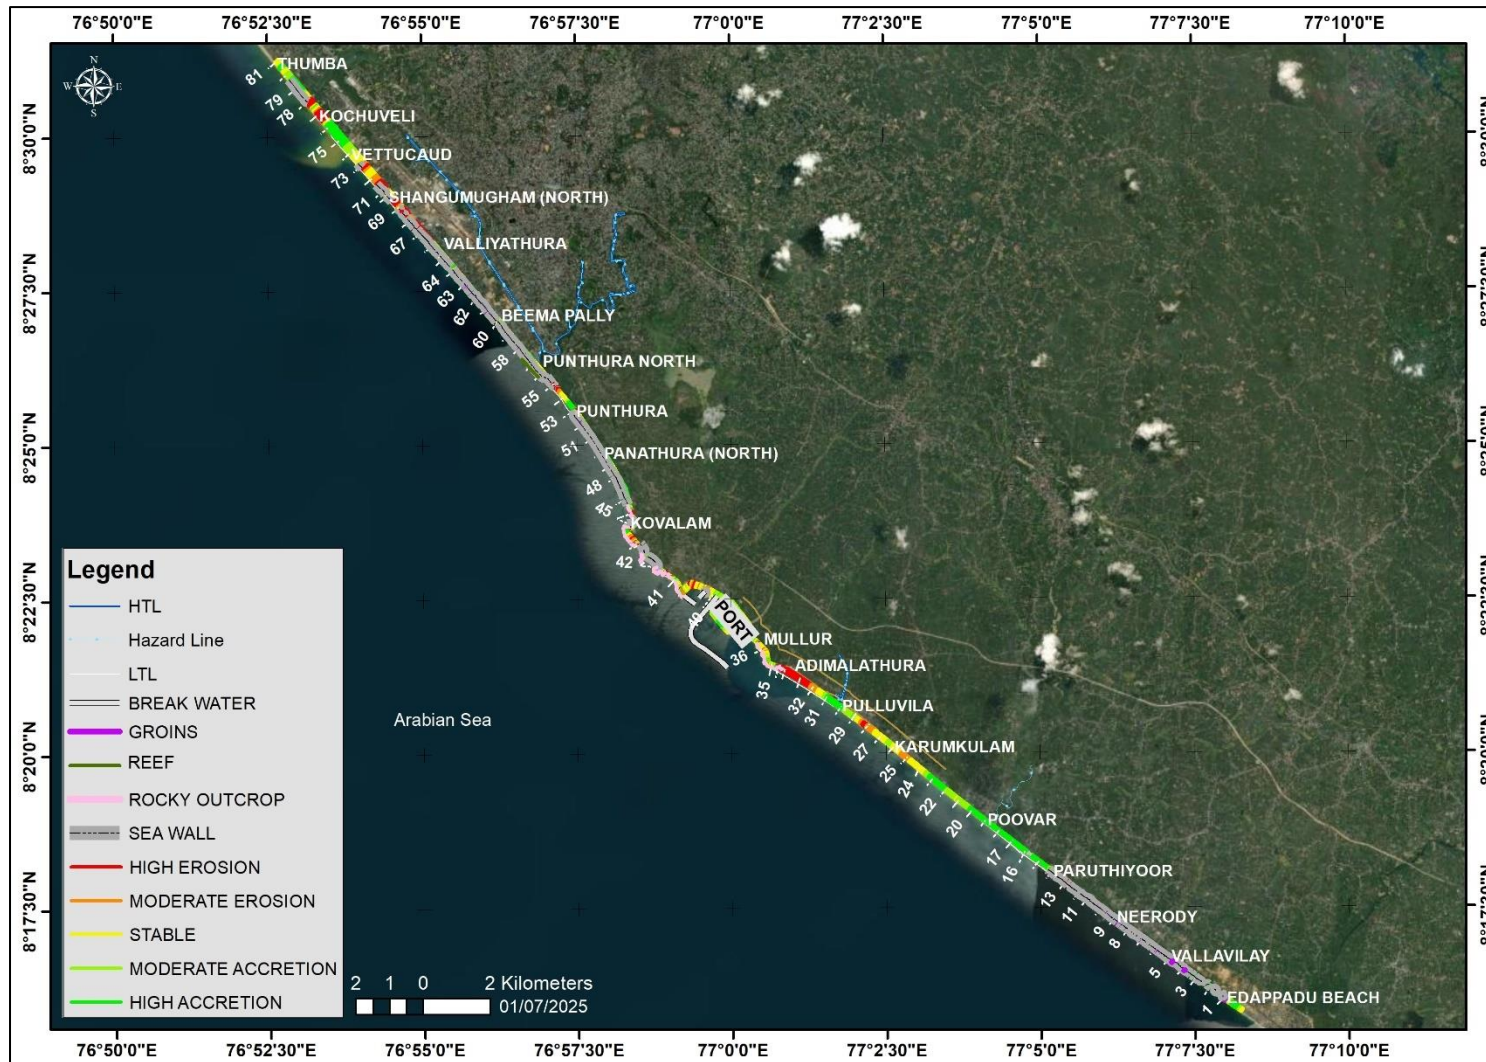
Figure A.34 Shoreline Change Map - July 2025

For July 2025, the shoreline change analysis shows erosion at Paruthiyoor (CSP11-13), Karumkulam (CSP25), Pulluvila (CSP28), Adimalathura (CSP32-35), Kovalam (CSP42-44), Punthura (CSP55), Beemapally (CSP61), Valliyathura to Shangumugham (CSP68-73), Kochuveli (CSP77-78) while accretion at Edapadu to Paruthiyoor (CSP01-10), Poovar (CSP14-24), Pulluvila (CSP29-31), Kovalam to Punthura (CSP41, 45-52, 54), Punthura North (CSP57-60), Valliyathura (CSP64-66), Vettucaud (CSP74-76), Thumba (CSP79-81).

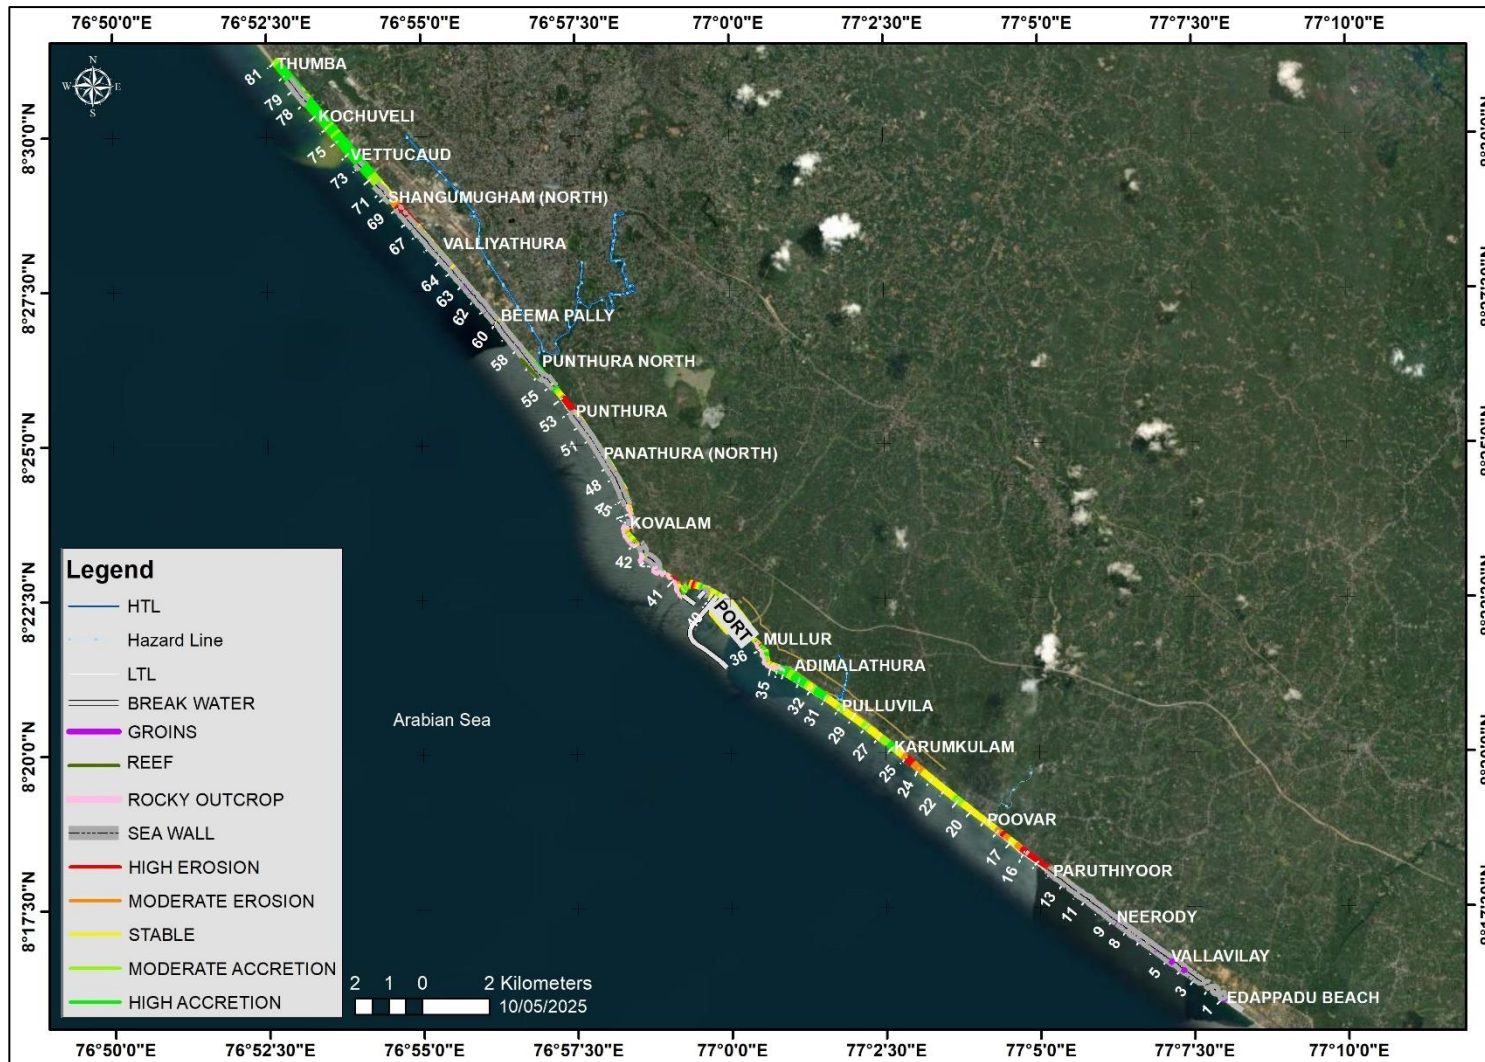
The monthly shoreline change analysis for September 2025 indicates erosion at Edappadu (CSP01), Poovar (CSP18), Karumkulam (CSP23), Mullur (CSP36), Punthura (CSP53), while accretion at Edappadu (CSP02), Paruthiyoor (CSP14-16), Poovar (CSP21), Karumukulam to Adimalathura (CSP24-33), Kovalam to Pannathura (CSP43-50), Punthura to Thumba (CSP54-81).

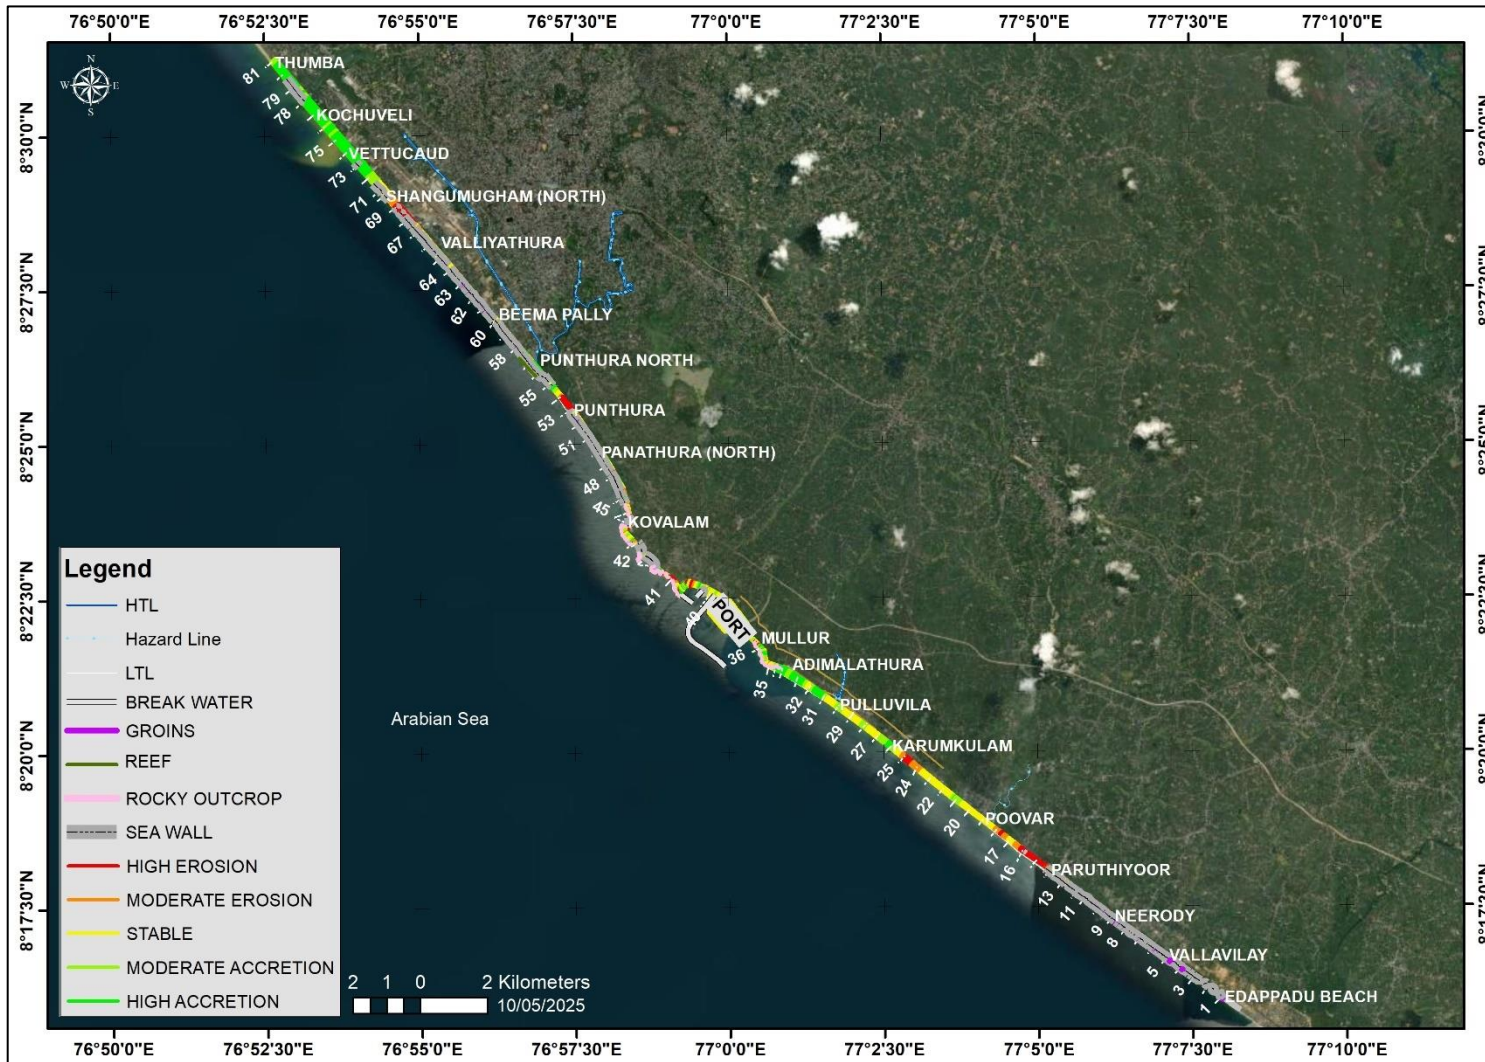
Figure A.39 Shoreline Change Analysis - Pre-Monsoon Period (April 2025-May 2025)

Pre-monsoon period (April 2025 to May 2025) exhibits erosion at at Paruthiyoor to Poovar (CSP11-18), Karumkulam (CSP24-25), Kovalam (CSP41, 45), Pannathura (CSP46, 48), Punthura (CSP53-54), Valliyathura (CSP63-64), Shangumugham (CSP66-70) while accretion at Edapadu to Neerody (CSP01-10), Karumkulam to Adimalathura (CSP26-36), Kovalam (CP42-44), Pannathura (CSP49-52), Punthura to Beemapally (CSP55-58, 61-62), Vettacud to Thumba (CSP70-81).

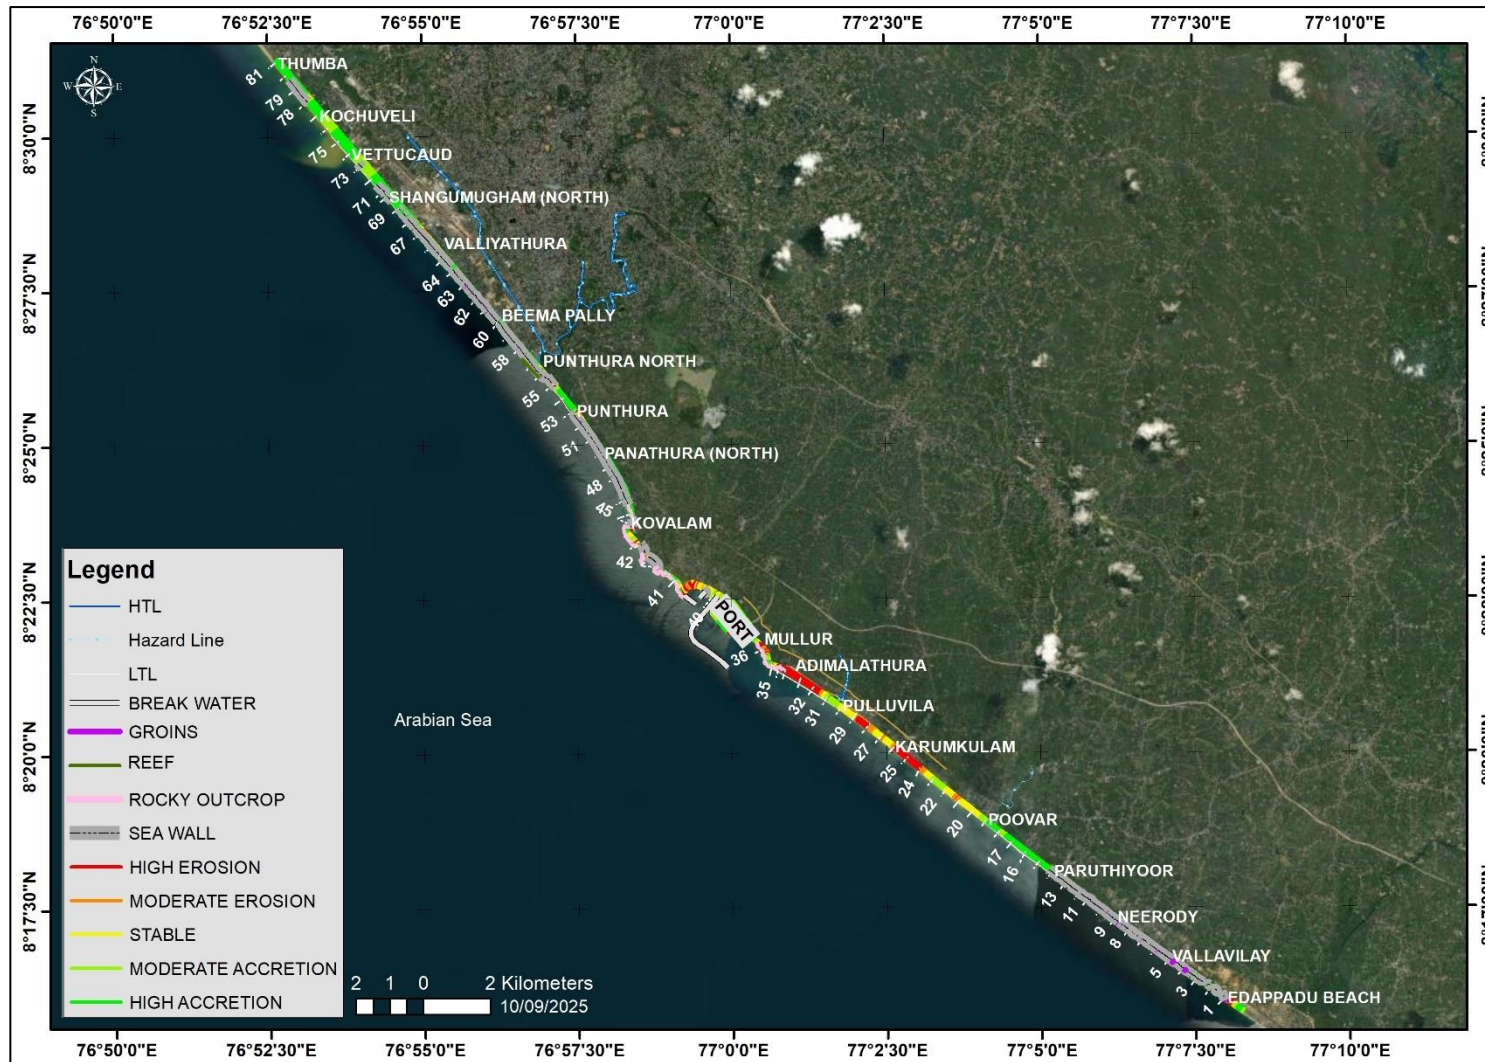
Figure A.40 Shoreline Change Analysis - Monsoon Period (June 2025 - September 2025)

Monsoon period for 2025 indicates erosion at Edapadu (CSP01), Poovar (CSP21), Karumkulam (CSP24-26), Pulluvila (CSP28-29), Adimalathura (CSP32-36), Kovalam (CS45), Punthura (CSP53), Valliyathura (CSP67), while accretion is noticed at Edapadu to Poovar (CSP02-20, 22-24), Adimalathura (CSP30-31), Kovalam to Pannathura (CSP41-50), Punthura to Valliyathura (CSP54-66), Shangumugham to Thumba (CSP68-81).

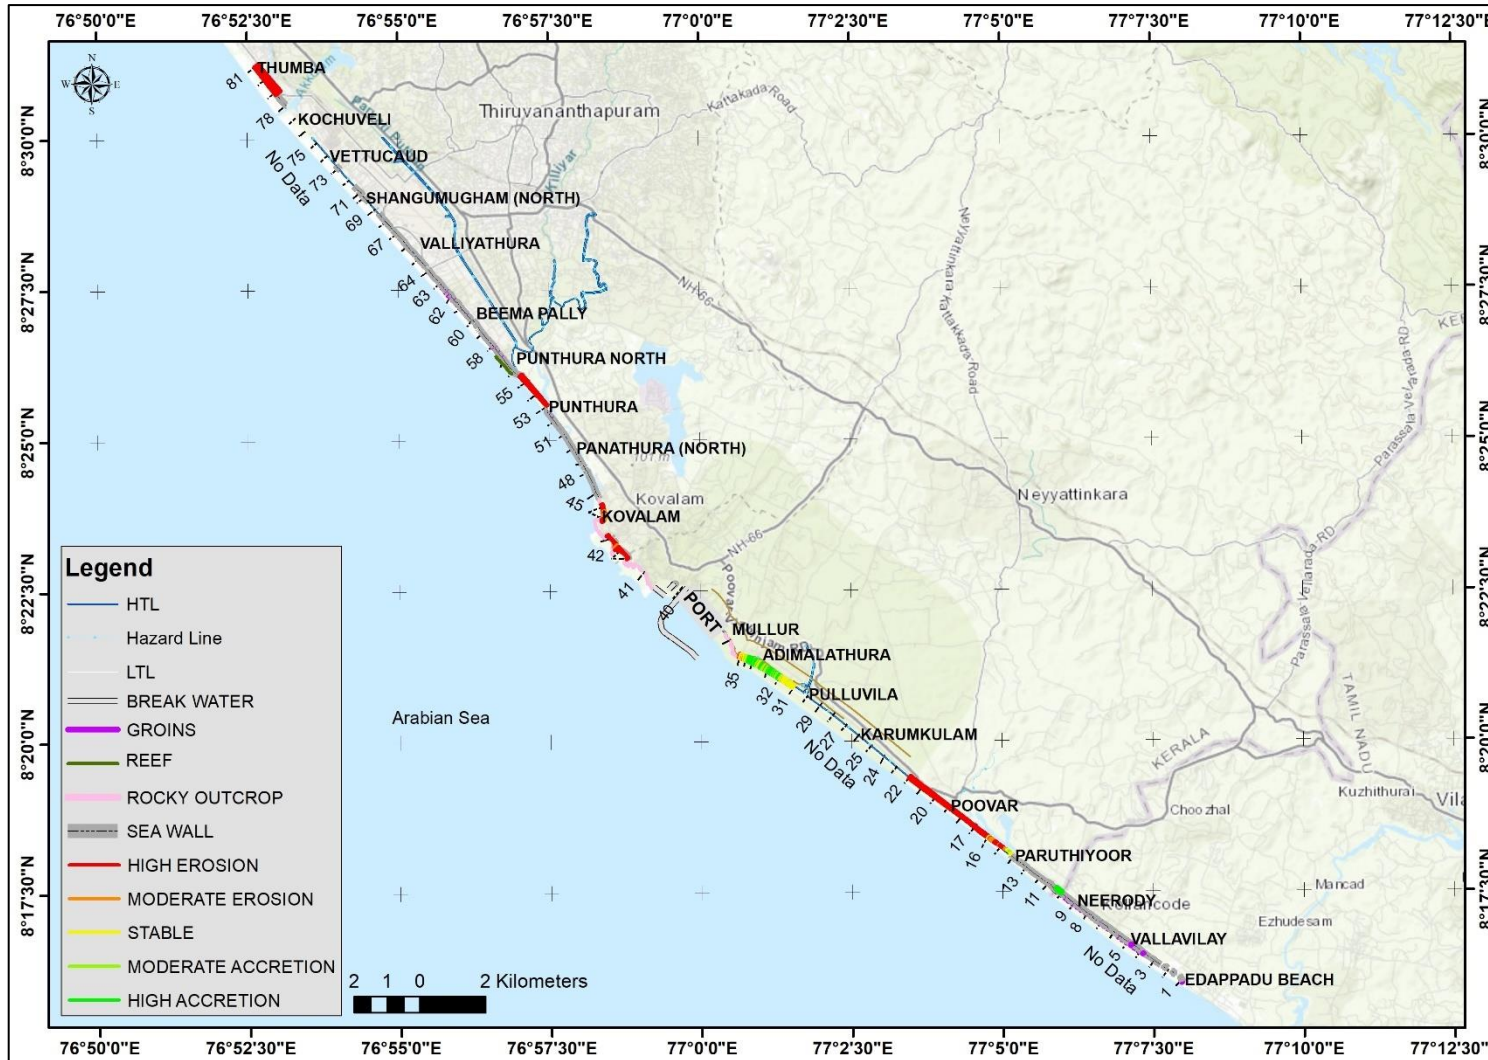
Figure A.55 Shoreline Change Map - May 2025

The monthly shoreline change analysis for May 2025 exhibits erosion at Paruthiyoor to Poovar (CSP15-22), Kovalam (CSP42-45), Punthura (CSP53-55), Thumba (CSP80-81), while accretion at Neerody (CSP10), Paruthiyoor (CSP14), Adimalathura (CSP32-35)

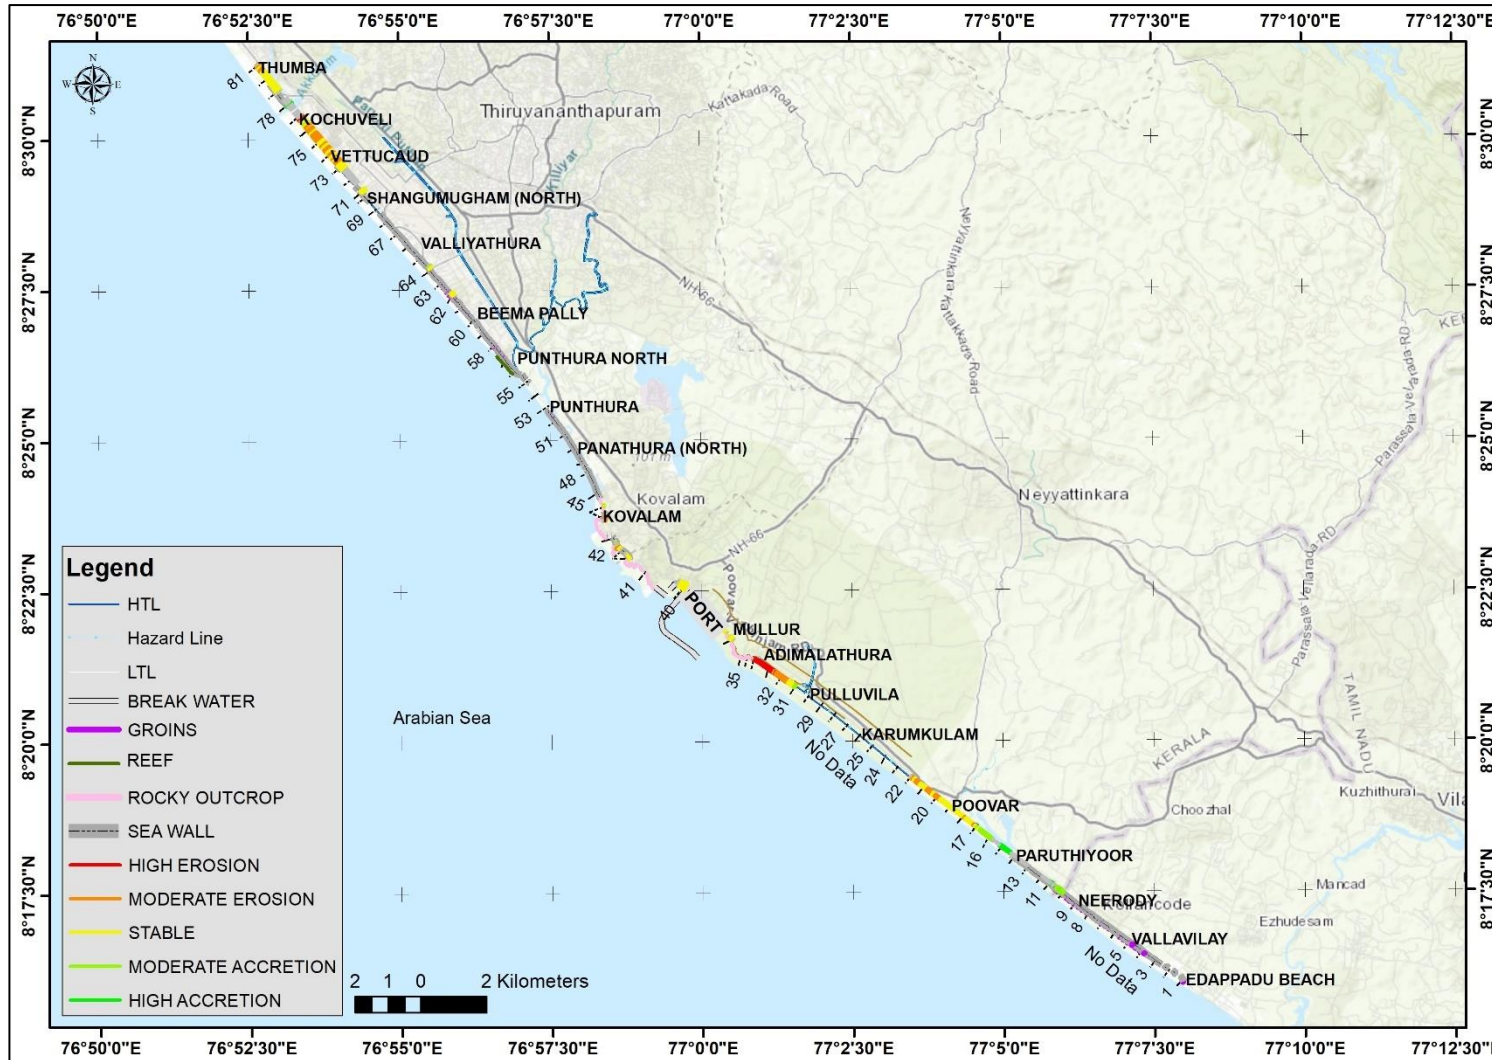
The monthly shoreline change analysis for August 2025 indicates accretion at Neerody (CSP10), Paruthiyoor (CSP13-17), while erosion at Poovar (CSP20-21), Adimalathura (CSP32-34), Kovalam (CSP45), Veetuacud to Kochuveli (CSP73-77).
