**SHORELINE CHANGE ANALYSIS OF VIZHINJAM COAST USING
BEACH PROFILES AND SATELLITE IMAGES**

**ANNUAL REPORT
(October 2020 to September 2021)**

ADANI VIZHINJAM PORT PVT LIMITED

**Coastal and Environmental Engineering Division
NATIONAL INSTITUTE OF OCEAN TECHNOLOGY
CHENNAI
June, 2022**

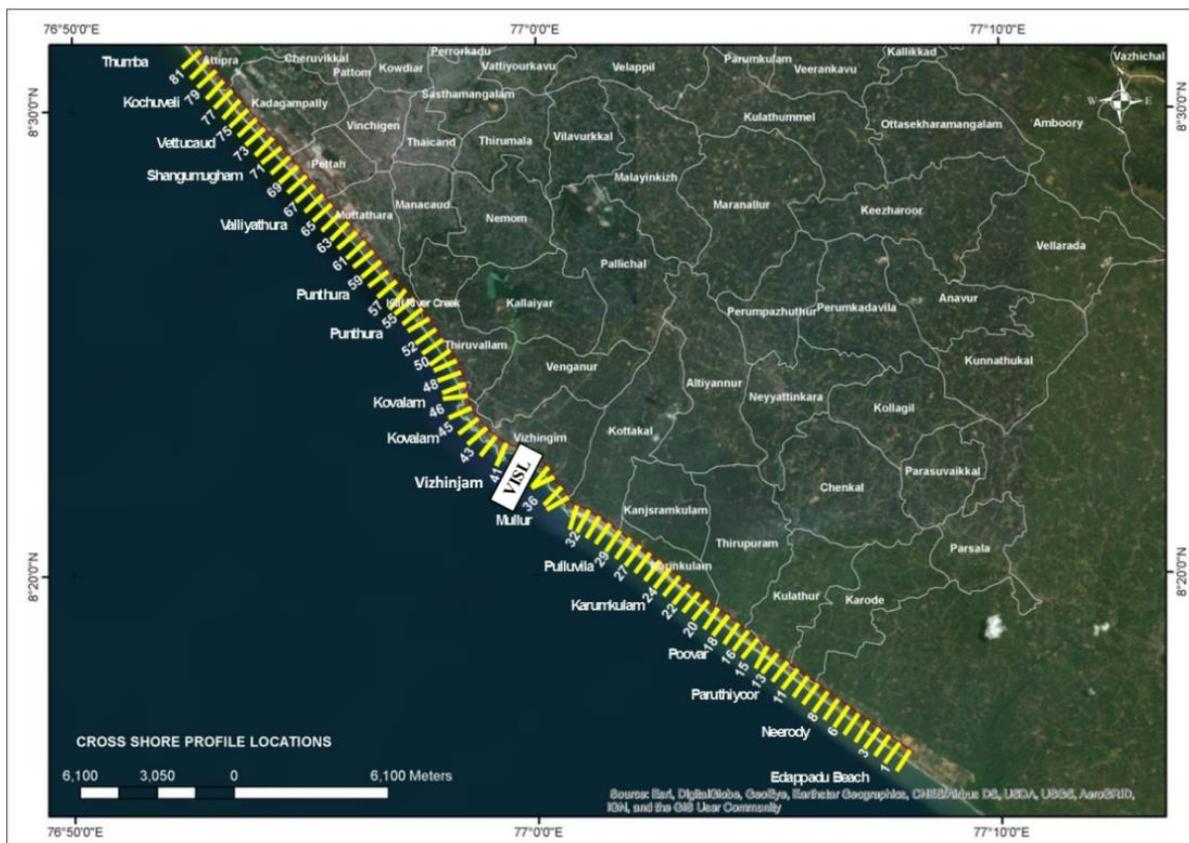
Figure 3.4 Beach Profiles lines

Shoreline Change analysis using Cross shore Profile (CSP) has been done as part of the Shoreline Monitoring Programme. CSP data is being collected monthly by the surveying agency every month at 81 profile lines along a stretch of 40 km covering the area of approximately 20 km south and 20 km north of the proposed Vizhinjam port (Since February 2015 to till date). The locations of the CSP lines are shown in **Figure 3.4**, and the corresponding landmarks and location names are given in Table 3.2. However, due to Covid-19 restrictions and rough sea condition along the Vizhinjam coast, during May 2021 and June 2021 only few locations (CSP36, 37, 75, 76, 77, 78, 79, 80, 81) were surveyed for onshore part and the offshore part of the cross-shore profiling could not be carried out for the months of October 2020, May 2021, June 2021 and July 2021. Hence these data have not been considered for the overall beach volume change analysis.

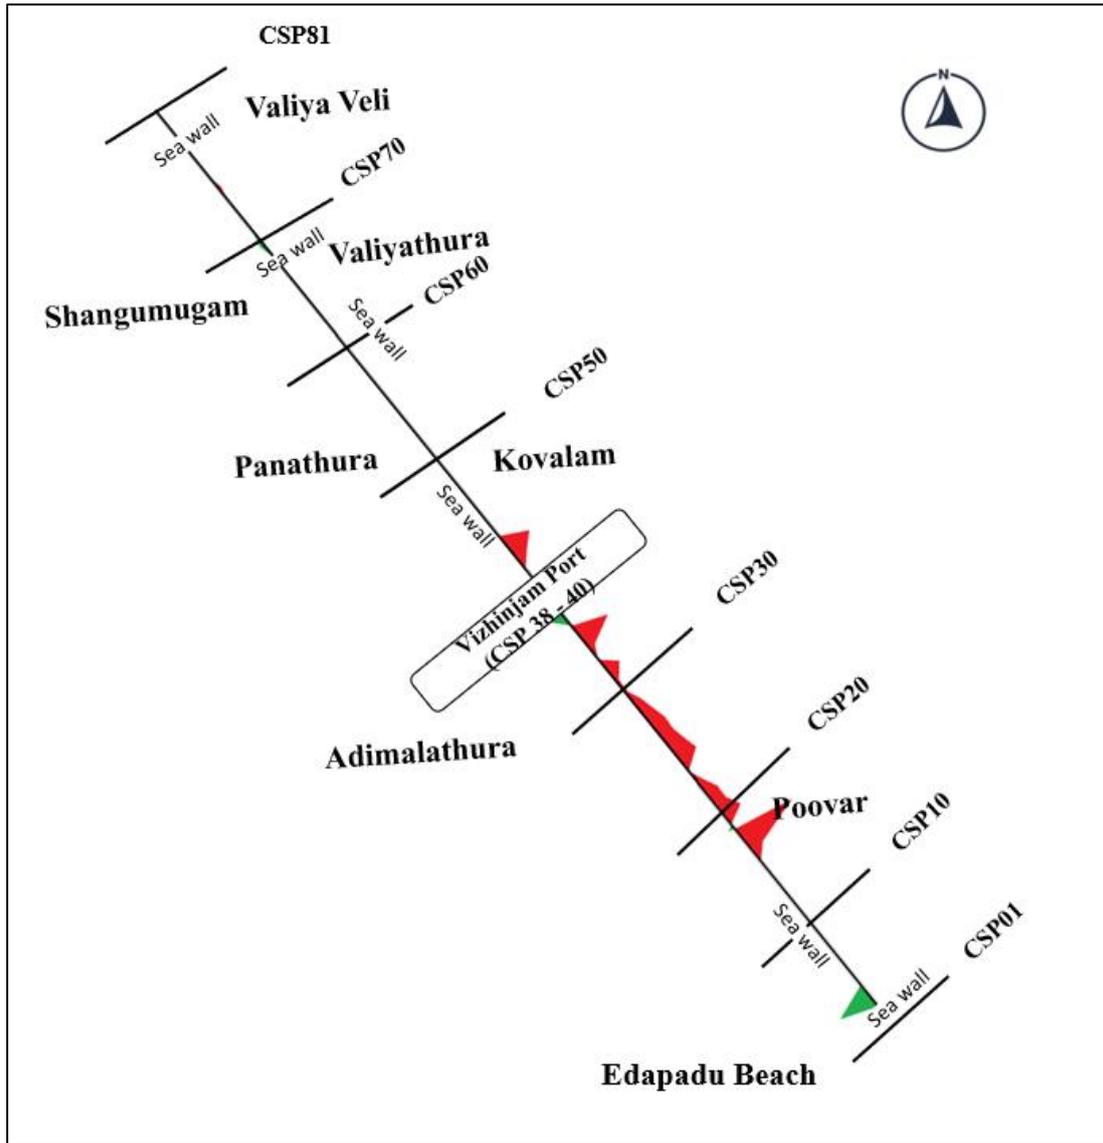
Figure 4.1 Monthly Beach Volume Changes in October 2020 in m³/m (onshore)

- During October 2020 Beach shown erosion in most of the locations. Accretion at Edapadu beach (CSP02), Poovar South (CSP17), Azhimala (CSP36), Pannathura (CSP51-52), Shangumugham (CSP69-71), Thumba (CSP81).
- During the month of November 2020, the sediment accretion has taken place over most of the locations. Erosion noted at Poovar (CSP16-18), Karumkulam (CSP24), Adimalathura (CSP31, CSP33), Mullur (CSP37), Pannathura to Punthura (CSP51-53), Valliyathura (CSP66), Shangumugham (CSP69), Valiyaveli (CSP78), and Thumba (CSP80).

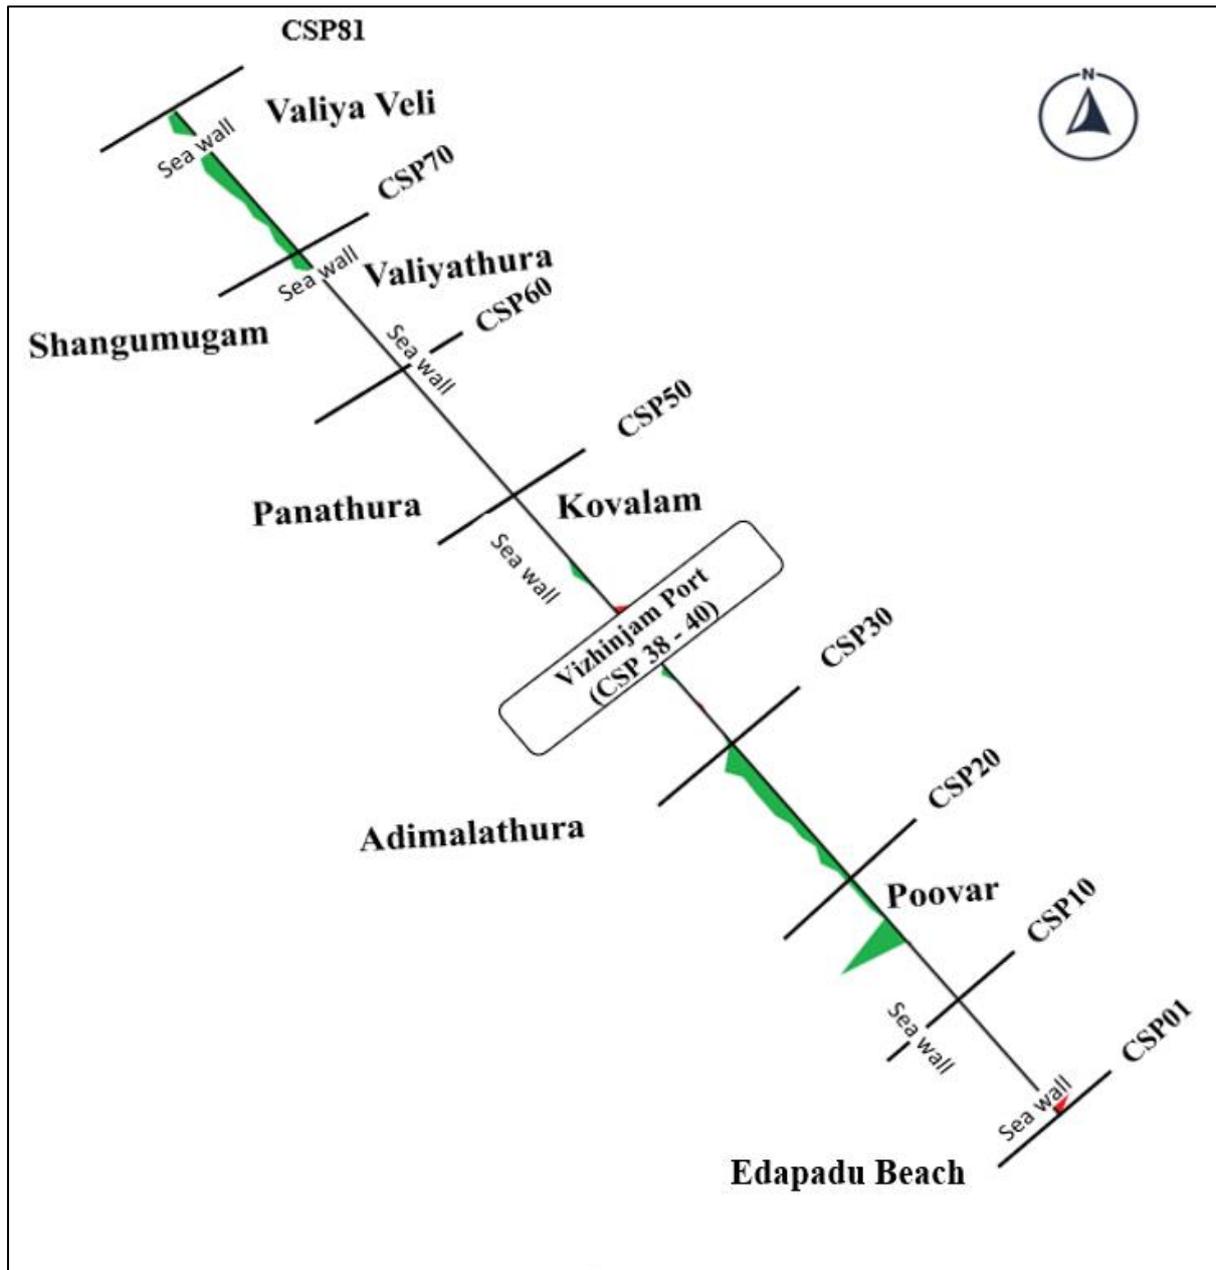
Figure 4.3 Monthly Beach Volume Changes in December 2020 in m³/m (onshore)

- In December 2020, the profile for the CSP42 found erroneous hence excluded from the analysis. Other than Edapadu beach (CSP02), Poovar (CSP15), Adimalathura (CSP33-34), Mullur (CSP37), Kovalam (CSP41), Pannathura to Punthura (CSP51-53), the beach was found to have accretion in most of the beaches.

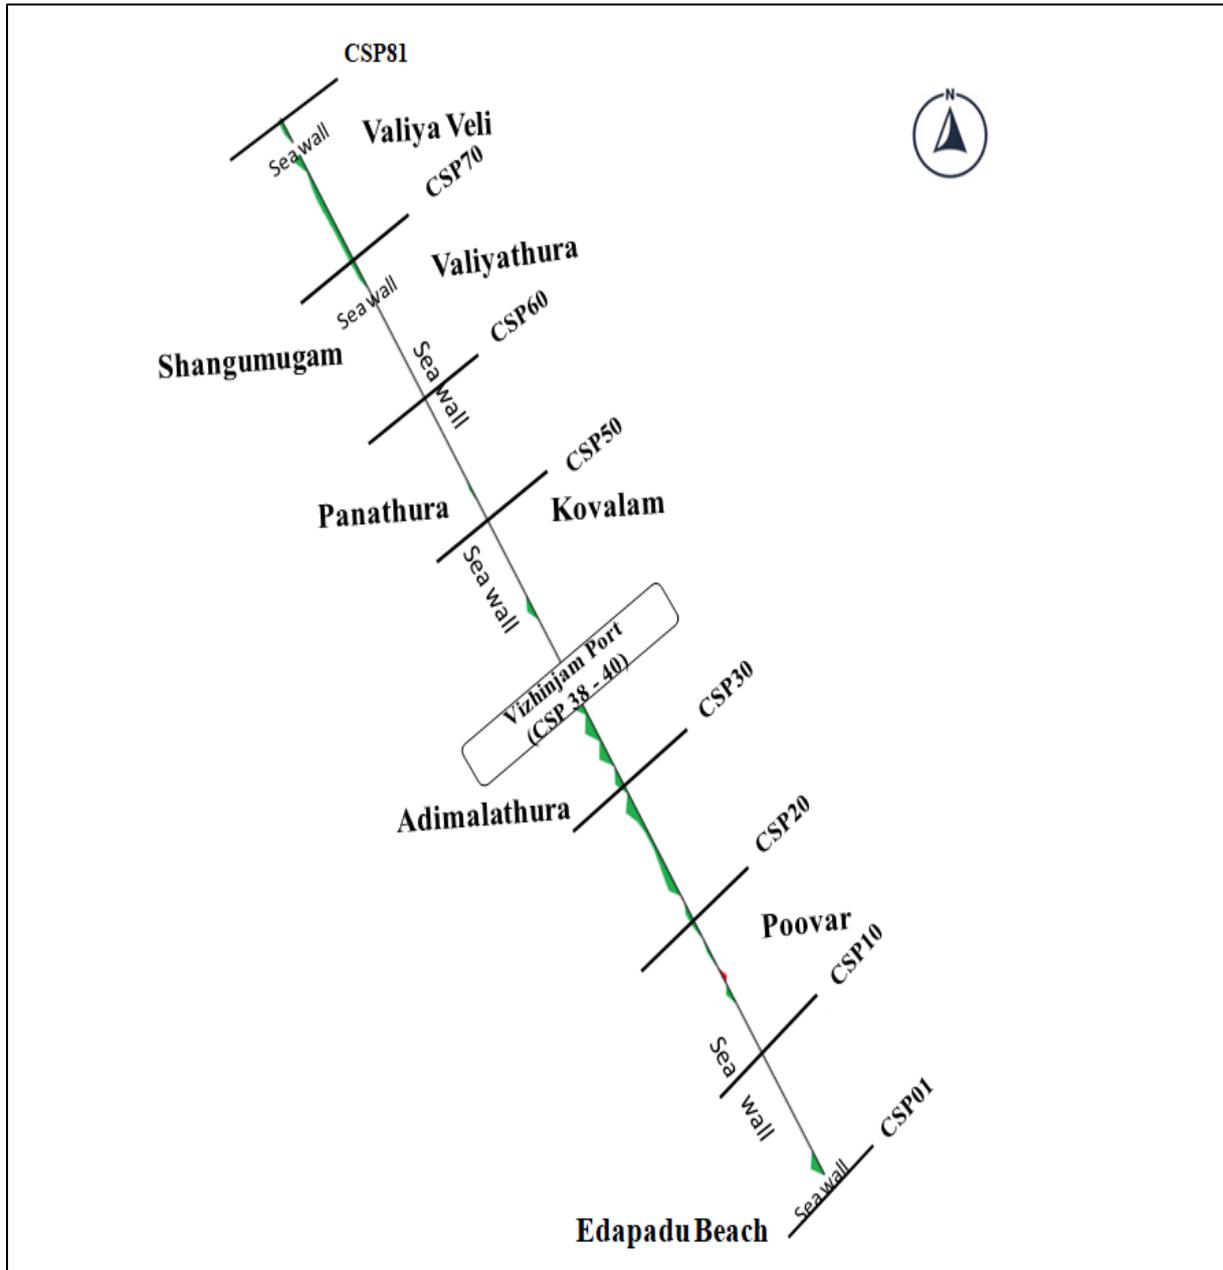
Figure 4.4 Monthly Beach Volume Changes in January 2021 in m^3/m (onshore)

- During the month of January 2021, the beach shown accretion trend over most of the locations. Erosion is noted at Poovar (CSP16), Karumkulam (CSP22), Kovalam (CSP41 and 43).

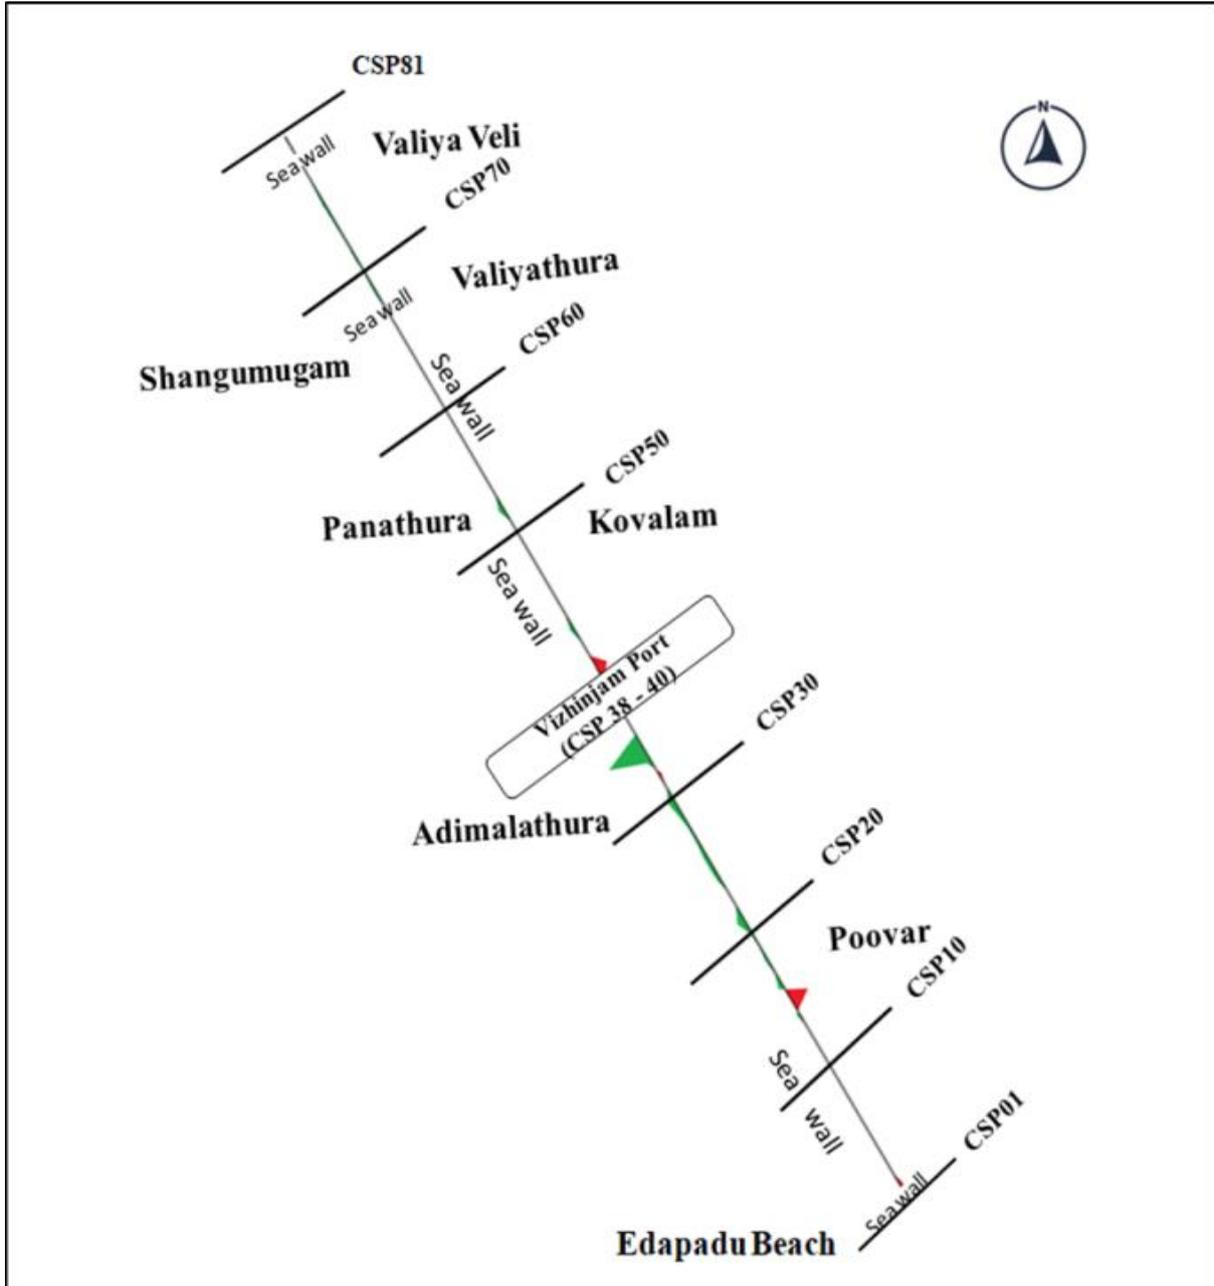
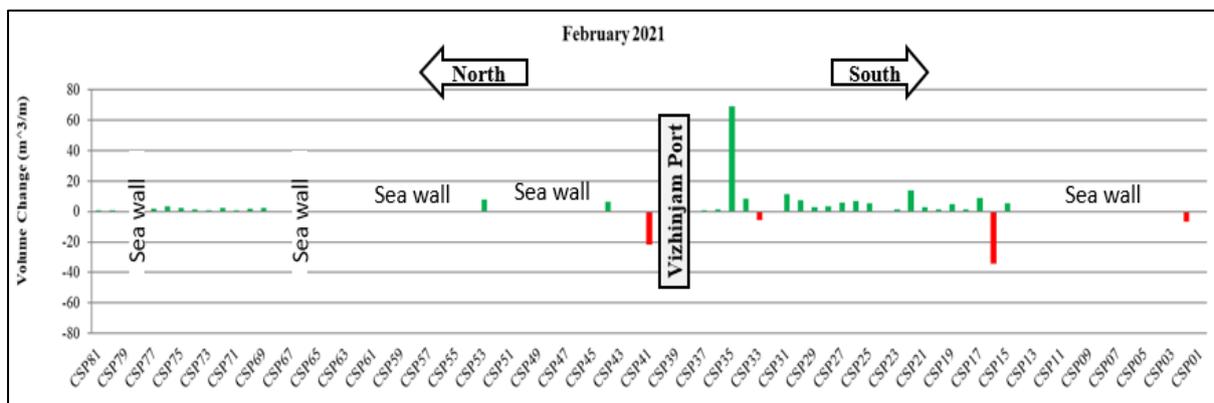
Figure 4.5 Monthly Beach Volume Changes in February 2021 in m^3/m (onshore)

- In February 2021, beach was found to have accretion along most of the locations. Erosion noticed at Edapadu beach (CSP02), Poovar (CSP16), Karumkulam (CSP24), Adimalathura (CSP33), Kovalam (CSP41-42), Pannathura (CSP52), and Valliyathura (CSP66).

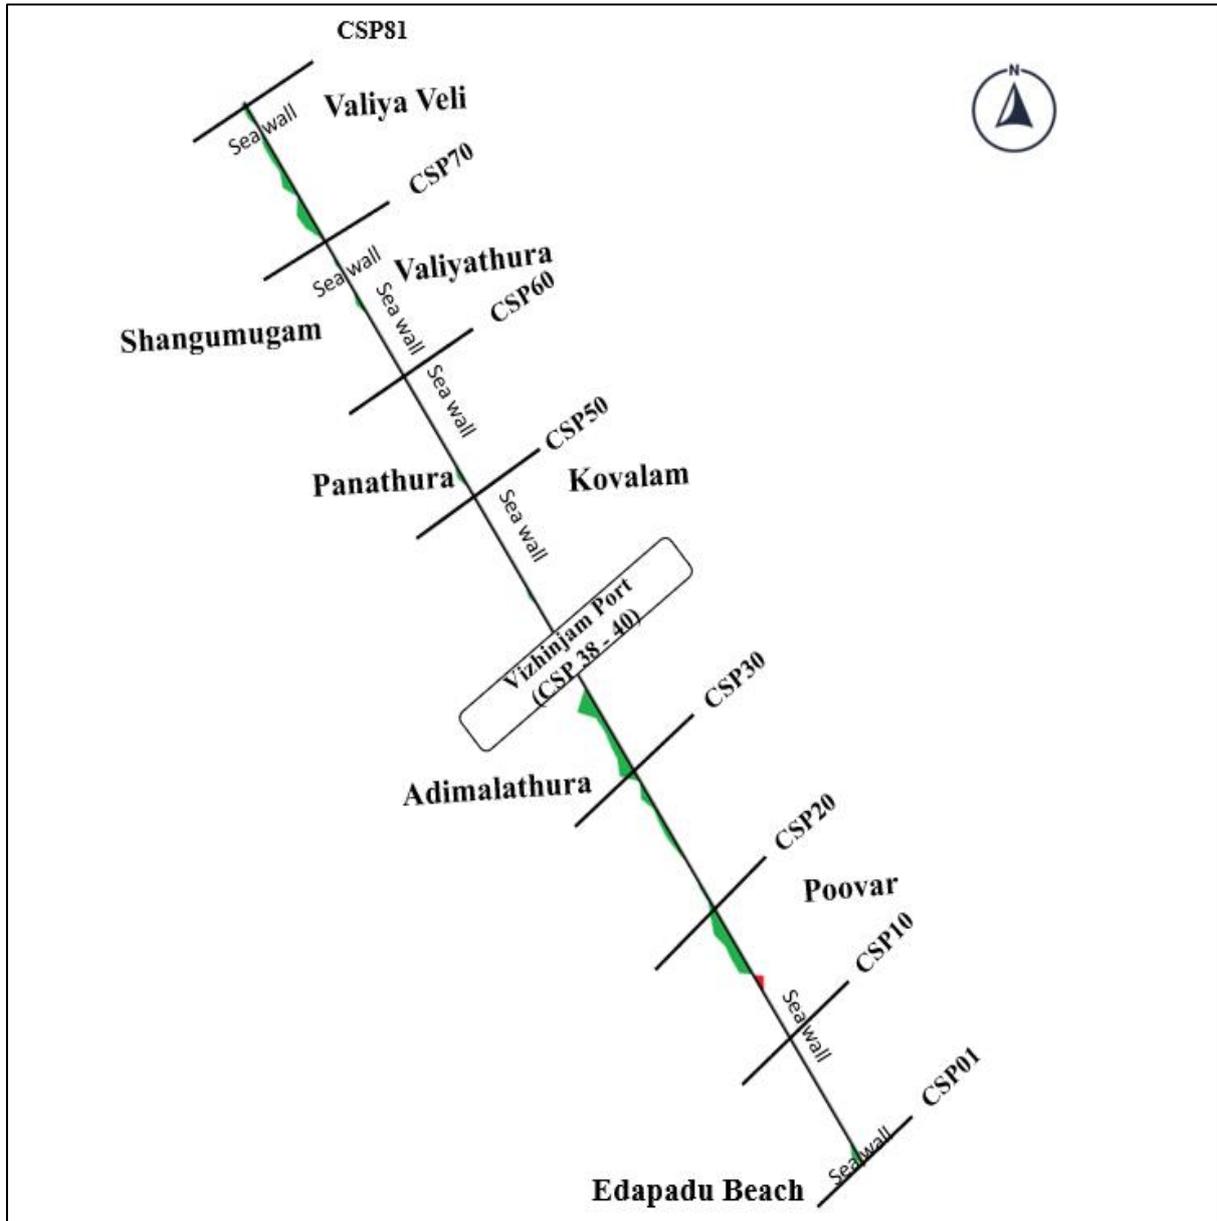
Figure 4.9 Monthly Beach Volume Changes in September 2021 in m^3/m (onshore)

- During September 2021 most of the beaches exhibits accretion trend. Erosions noticed at Poovar (CSP15), Kovalam (CSP42), and Shangumugham North (CSP70).

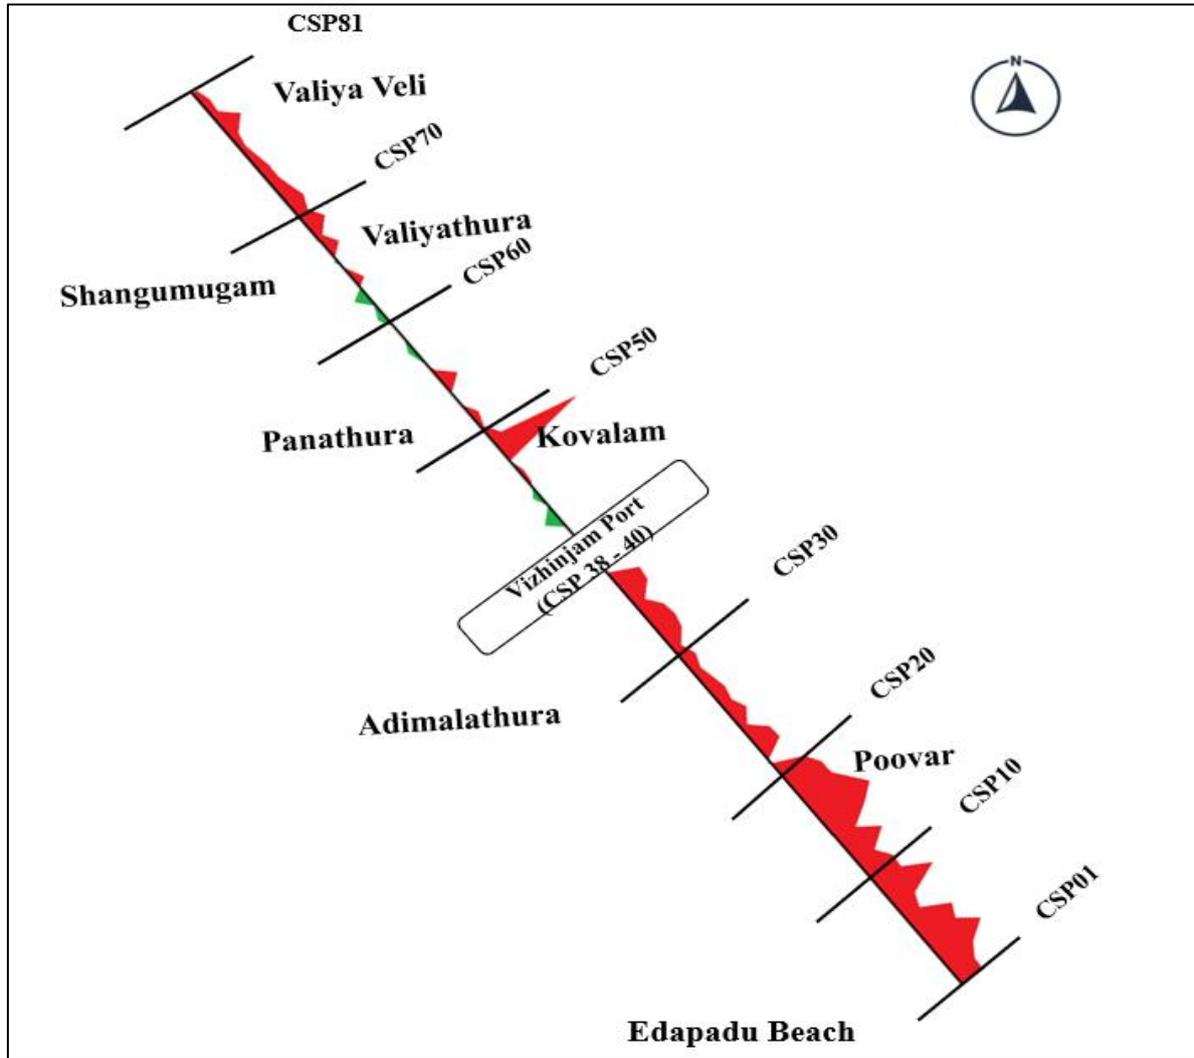
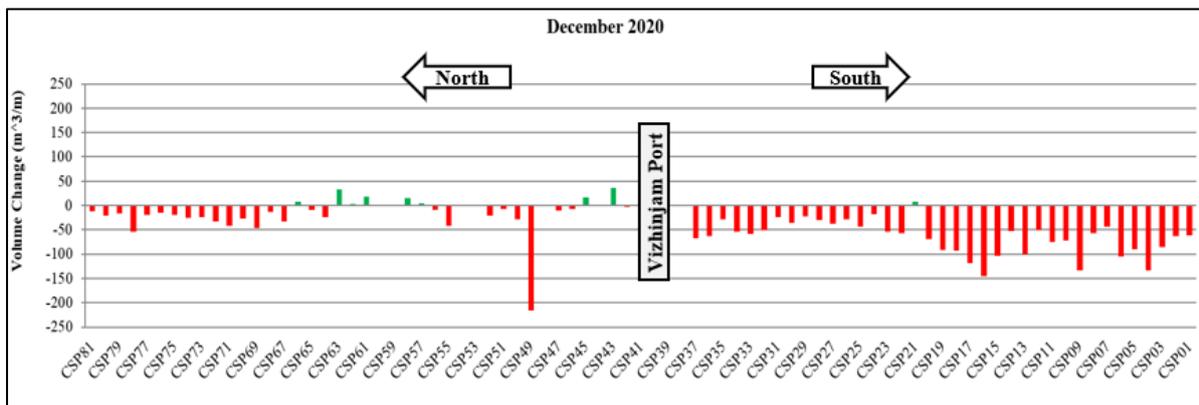
Figure 4.10 Monthly Beach Volume Changes in December 2021 in m³/m (offshore)

- In December 2020, at CSP41 there was no offshore data hence this location excluded from the analysis. Most of the locations on offshore found to have erosion. Accretion found at Poovar (CSP21), Kovalam (CSP43-45), Punthura (CSP54), and Punthura to Beemapally (CSP57-59), Cheriyaathura to Valliyathura (CSP61-63), and Valliyathura (CSP66).

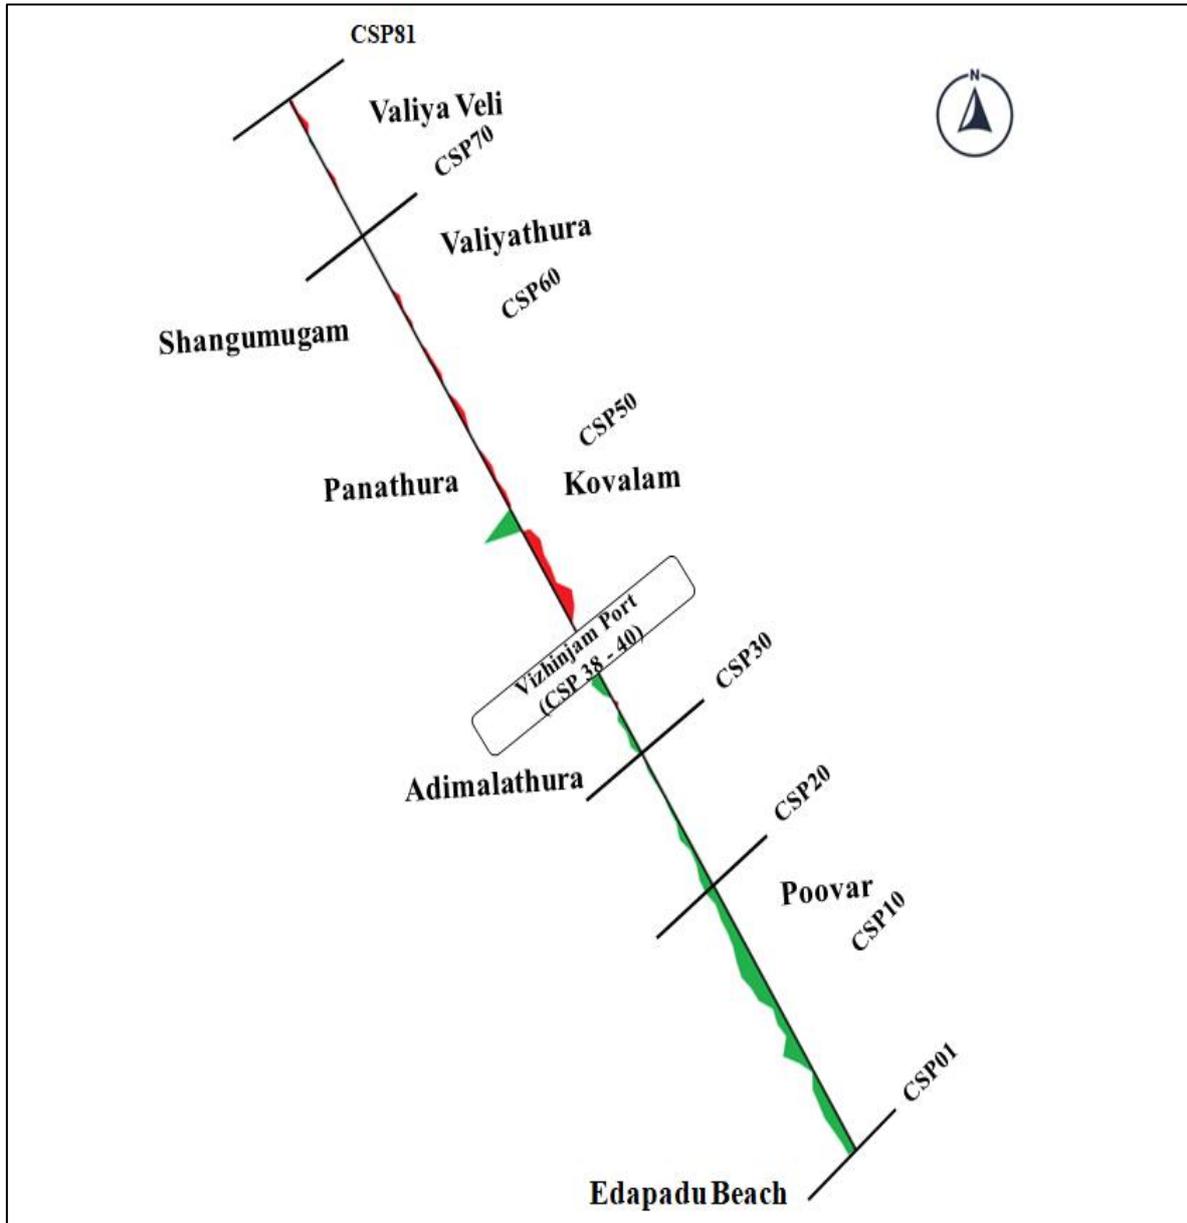
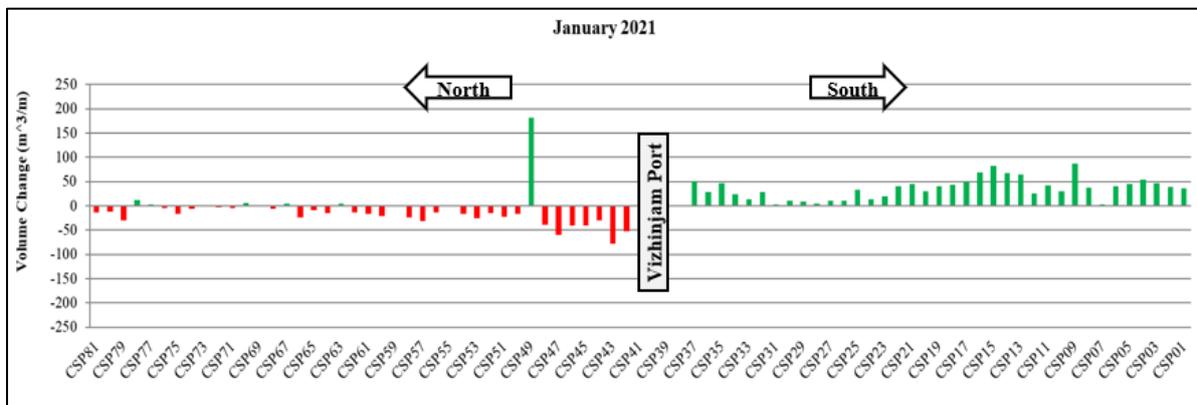
Figure 4.11 Monthly Beach Volume Changes in January 2021 in m^3/m (offshore)

- During the month of January 2021, the locations south of the port shown accretion and on the northern side most of the locations shown erosion. On northern side accretion found at Pannathura (CSP49), Valliyathura (CSP64 and 67), Shangumugham (CSP70), Vettucaud (CSP73), Kochuveli to Valiyaveli (CSP77-78).

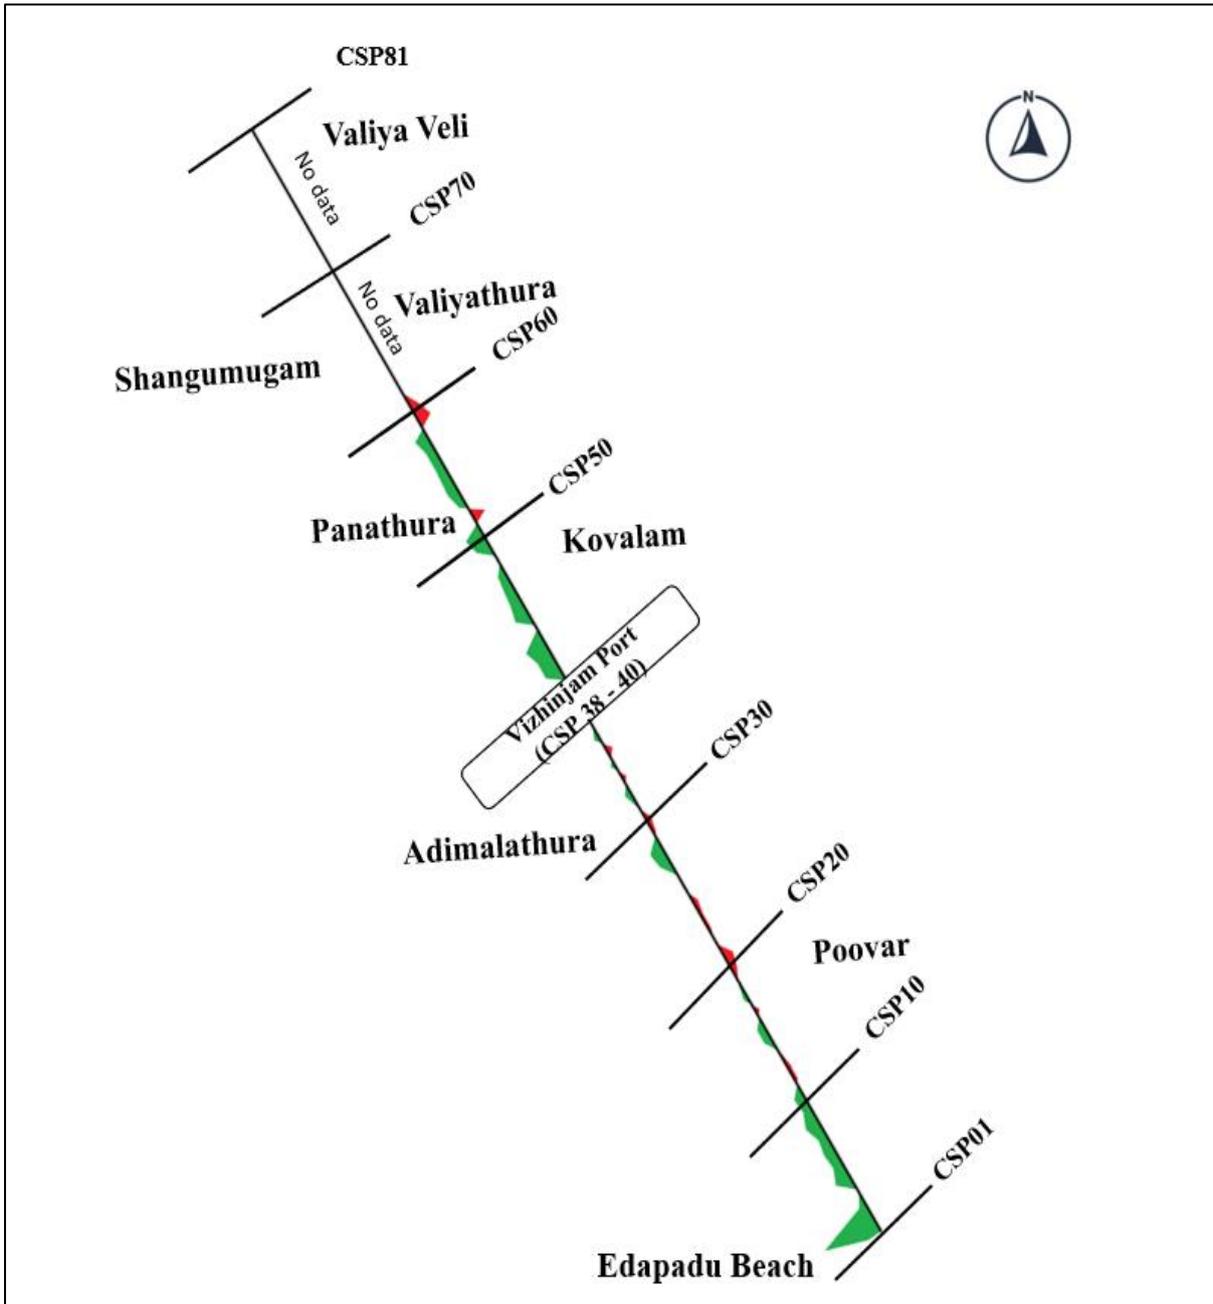
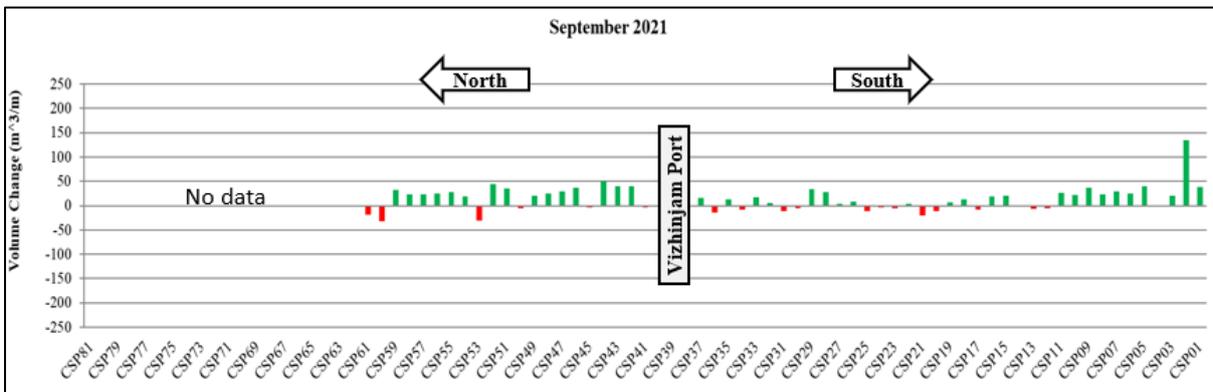
Figure 4.15 Monthly Beach Volume Changes in September 2021 in m³/m (offshore)

- In September 2021 the locations CSP62 to CSP81 were excluded from the analysis as the offshore data could not be collected due to Cyclone Gulab. Locations Pozhiyur to Paruthiyoor (CSP12-14), Poovar South (CSP17), Poovar (CSP20-21), Karumkulam (CSP23-25), Pulluvila to Adimalathura (CSP30-31), Adimalathura (CSP34), Mullur (CSP36), Kovalam (CSP41), Kovalam (CSP45), Pannathura North (CSP50), Punthura (CSP53), Beemapally to Cheriyaathura (CSP60-61) exhibits erosion during September 2021.

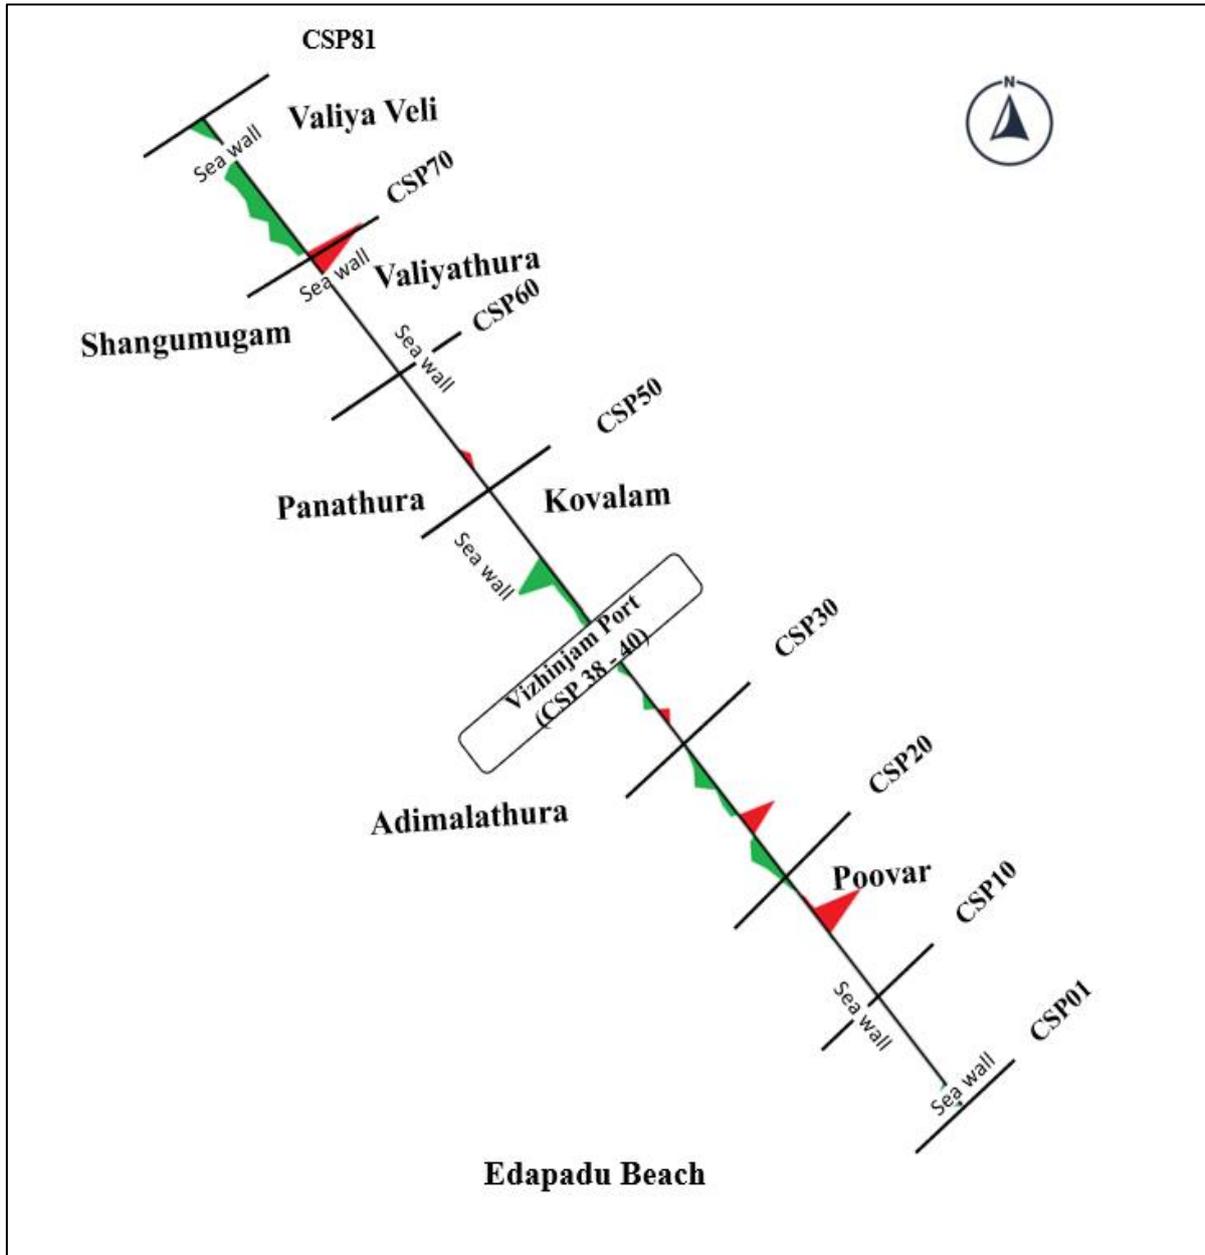
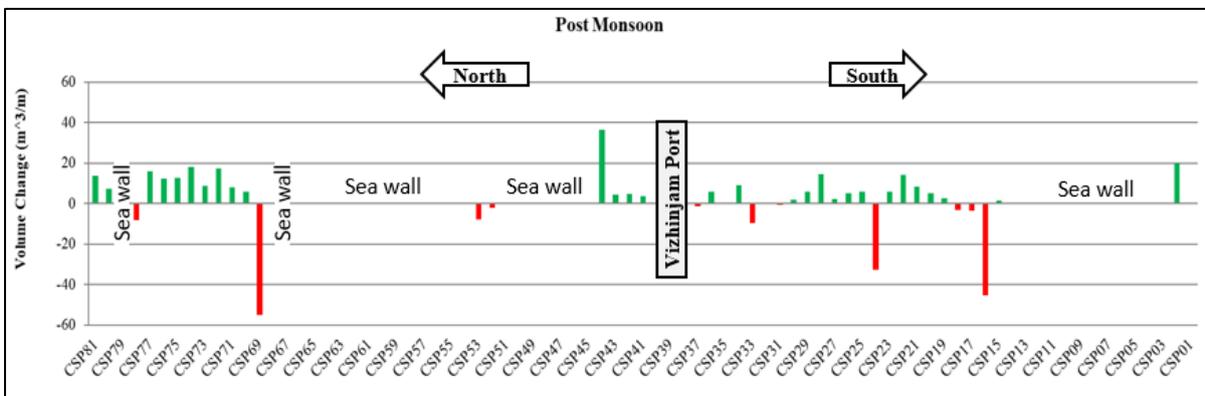
Figure 4.16 Seasonal Beach Volume Changes during Post Monsoon in m^3/m (onshore)

During the post monsoon (October 2020 to November 2020) the sediment accretion has taken place over most of the locations on onshore part. The location CSP32 and CSP35 are not included in the analysis as there is no data. Erosion noted at Poovar (CSP16-18), Karumkulam (CSP24), Adimalathura (CSP31, CSP33), Mullur (CSP37), Pannathura to Punthura (CSP51-53), Valliyathura (CSP66), Shangumugham (CSP69), Valiyaveli (CSP78), and Thumba (CSP80) as shown in **Figure 4.16**. The offshore change during this period could not be carried out as there was no offshore data in October 2020.

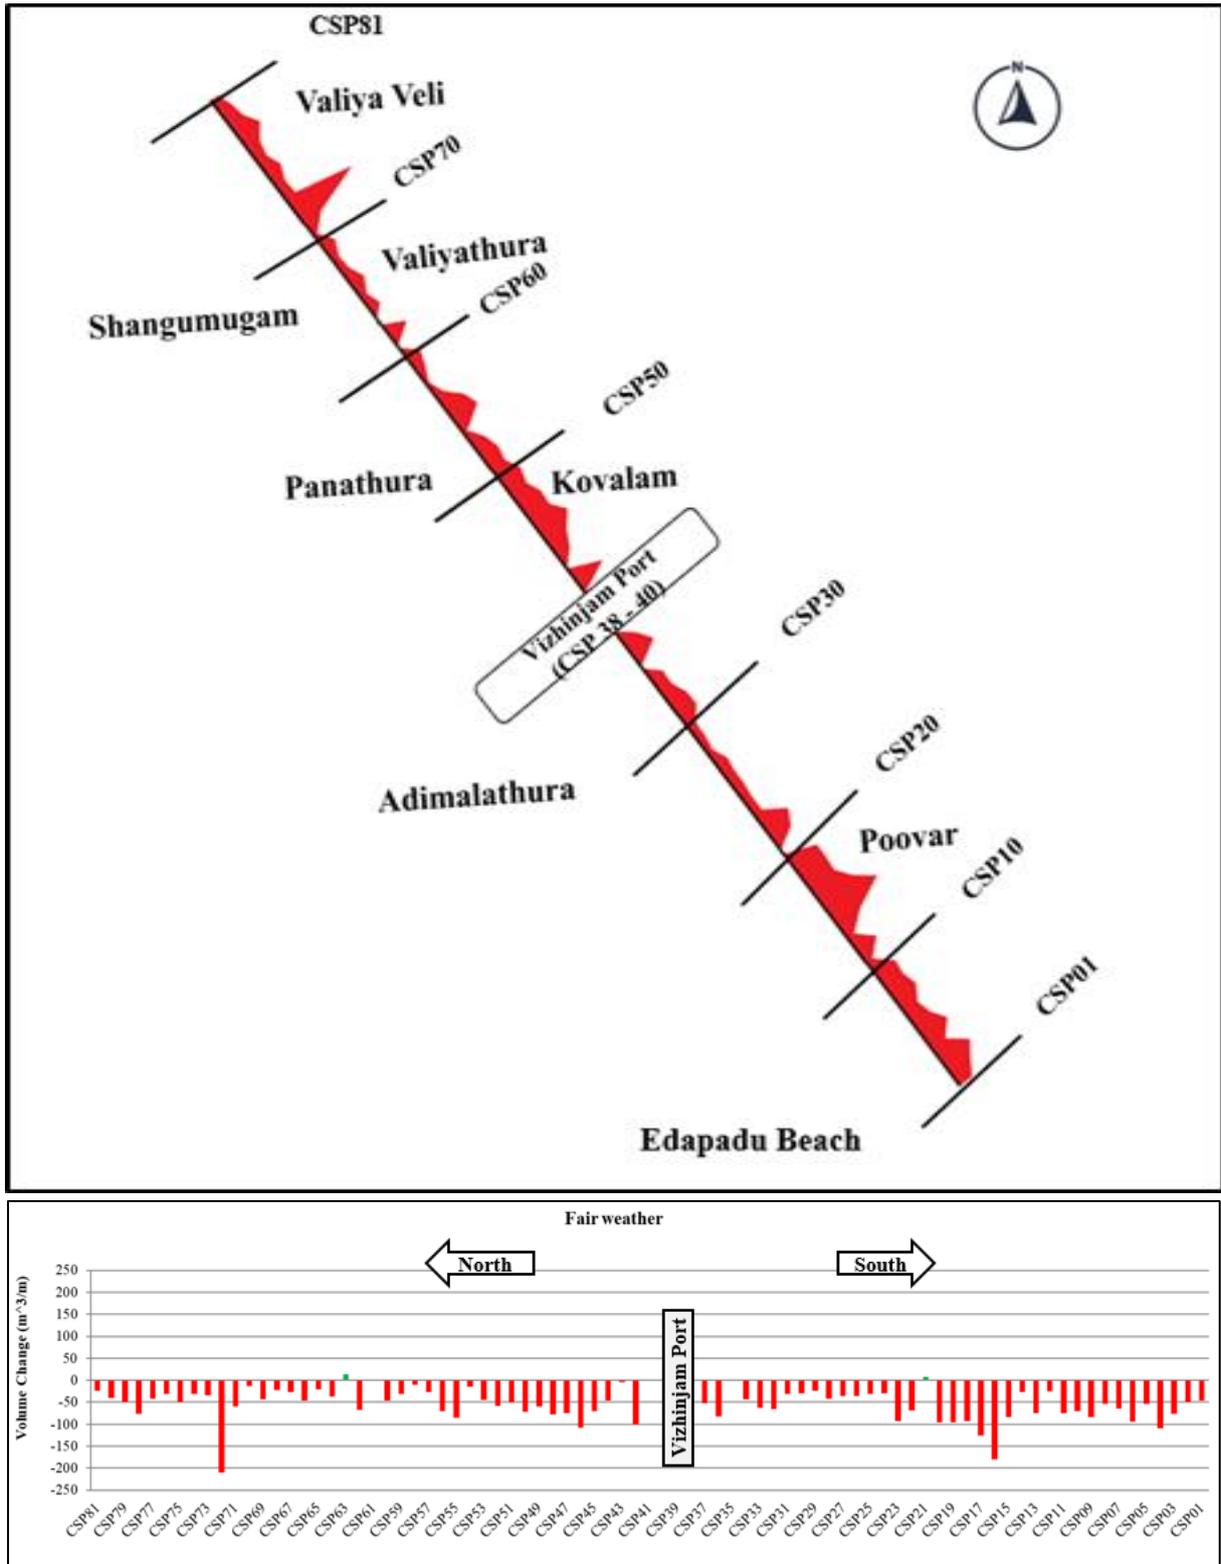
Figure 4.18 Seasonal Beach Volume Changes during Fair weather period in m^3/m (offshore)

During the same period on the offshore (**Figure 4.18**) all the locations except at Cheriyaathura (CSP61), Valliyathura (CSP63) and Poovar (CSP21) exhibit erosion. Edappadu beach (CSP02), Poovar (CSP18-19), Karumkulam (CSP25-26), Kovalam (CSP43), Pannathura to Punthura (CSP51-53), Kochuveli (CSP77) and Thumba (CSP81) shows erosion.

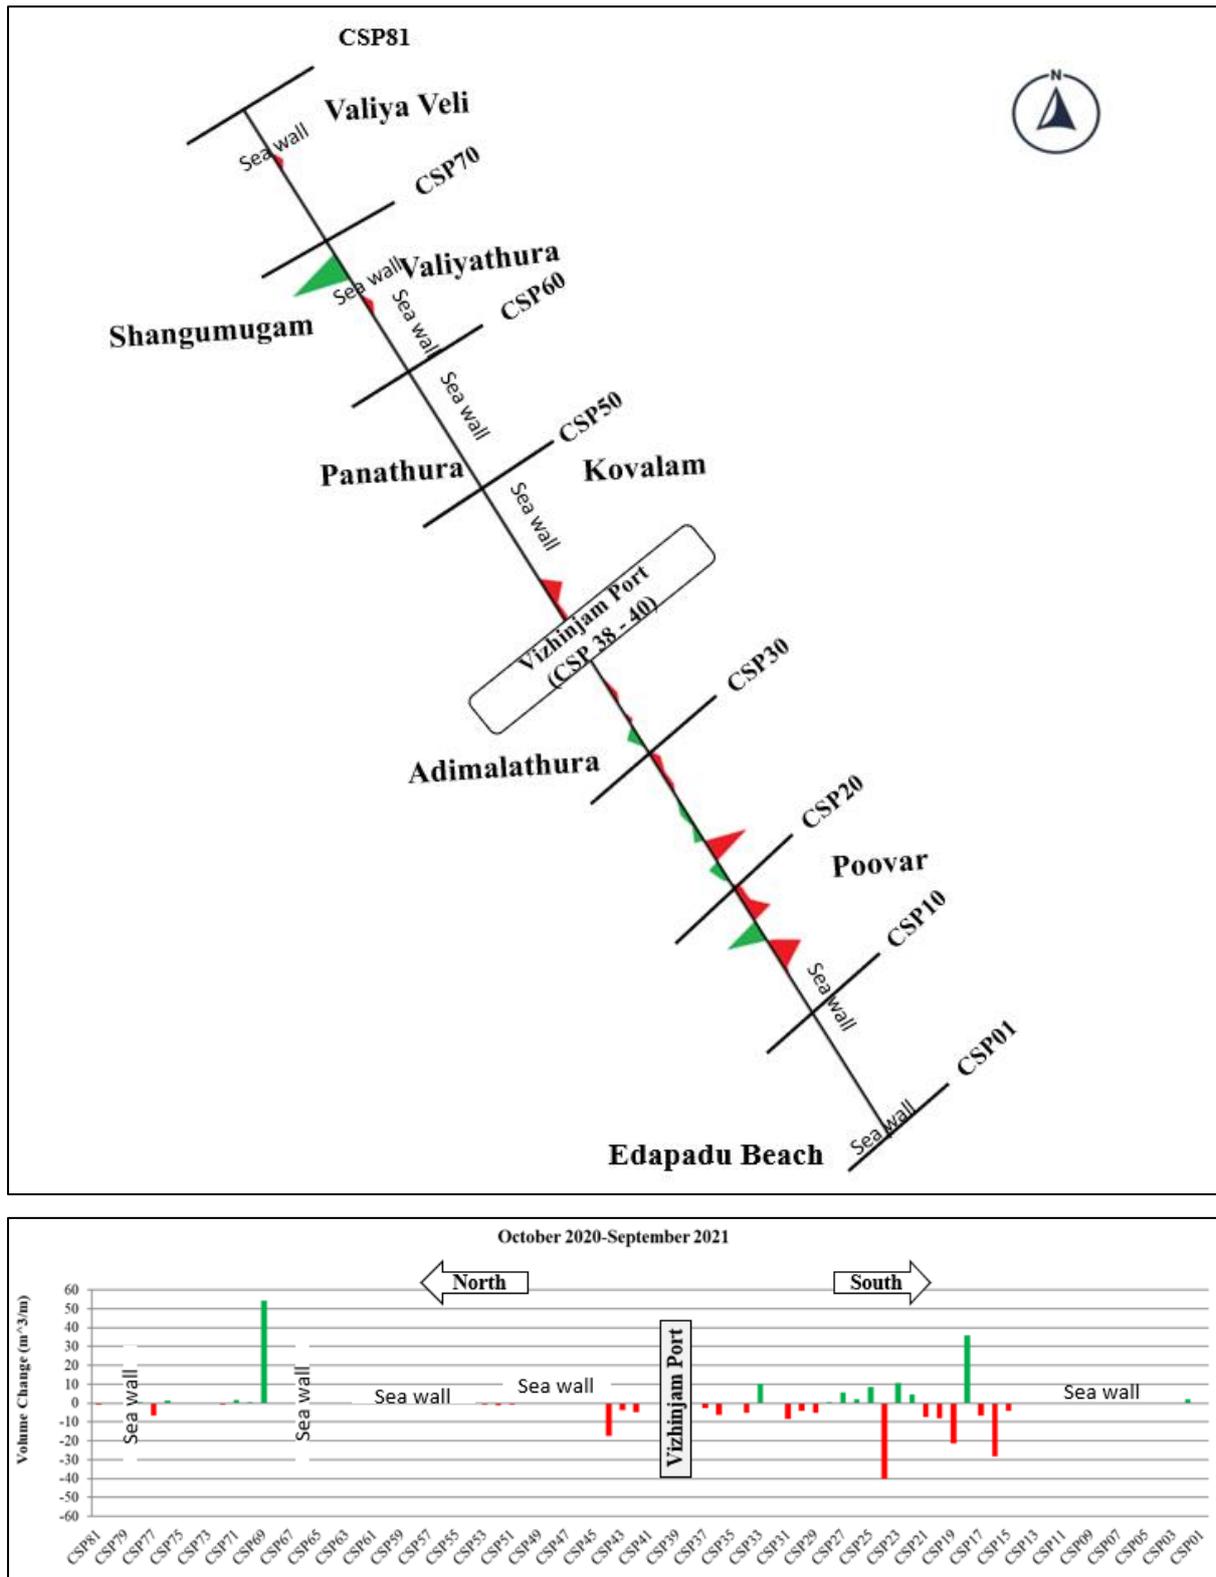
Figure 4.19 Overall Beach Volume Changes - October 2020 to September 2021 in m³/m

The beach volume change for October 2020 to September 2021 could be carried out only for the onshore part as there was no offshore data during October 2020. This analysis is done by comparing the profiles of September 2021 with October 2020. CSP32, CSP35 and CSP41 were excluded from the analysis as there is no data. During this period, the beach shown erosion at Poovar (CSP15-17 and CSP19-21), Karumkulam (CSP24), Pulluvila to Adimalathura (CSP29-31), Adimalathura (CSP34), Mullur (CSP36-37), Kovalam (CSP42-22), Pannathura to Punthura (CSP51-53), Valliyathura (CSP66), Vettucaud to Kochuveli (CSP72-75), Kochuveli (CSP77) and Thumba (CSP81). Accretion found at Edapadu beach (CSP02), Poovar (CSP18), Karumkulam (CSP22-23), Karumkulam to Pulluvila (CSP25-28), Adimalathura (CSP33), Shangumugham (CSP69-71), Valiyaveli (CSP78) and Thumba (CSP80). The results are shown in **Figure 4.19** and in **Table 4.3**.
