**SHORELINE CHANGE ANALYSIS OF VIZHINJAM COAST USING
BEACH PROFILES AND SATELLITE IMAGES**

**ANNUAL REPORT
(October 2020 to September 2021)**

ADANI VIZHINJAM PORT PVT LIMITED

**Coastal and Environmental Engineering Division
NATIONAL INSTITUTE OF OCEAN TECHNOLOGY
CHENNAI
June, 2022**

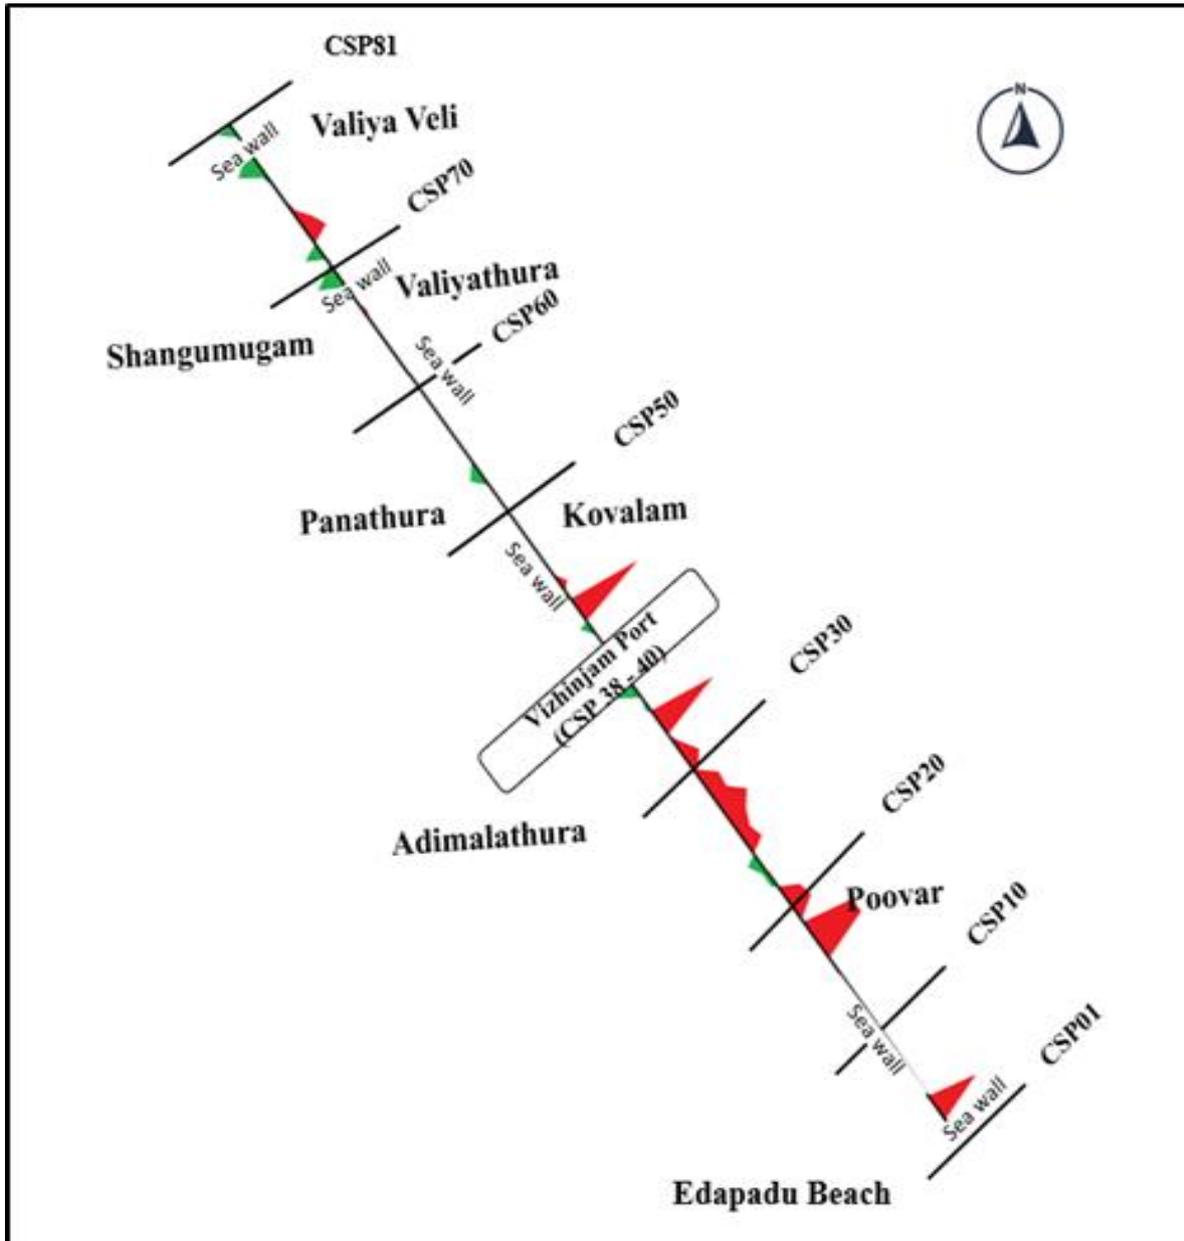
Figure 4.20 Beach Volume Changes during October 2019 and October 2020 in m^3/m (onshore)

The comparison between October 2019 and October 2020 shows erosions at Edapadu beach (CSP02), Poovar (CSP15-16 and CSP18-19), Karumkulam to Adimalathura (CSP23-31), Adimalathura (CSP33), Kovalam (CSP42 and 44), Pannathura (CSP51-52), Valliyathura (CSP66) and Vettucaud to Kochuveli (CSP72-75) on the onshore. At locations Poovar (CSP16), Poovar to Karumkulam (CSP20-22), Adimalathura (CSP34), Mullur (CSP36-37), Kovalam (CSP41), Kovalam (CSP43), Punthura (CSP53), Shangumugham (CSP69 and CSP71), Kochuveli to Valiyaveli (CSP76-78) and Thumba (CSP 80-81) accretion taken place on onshore side in October 2020 compared to October 2019. There was no offshore data for the month October 2021 to compare with October 2019. The results have been presented in **Figure 4.20** and in **Table 4.4**.

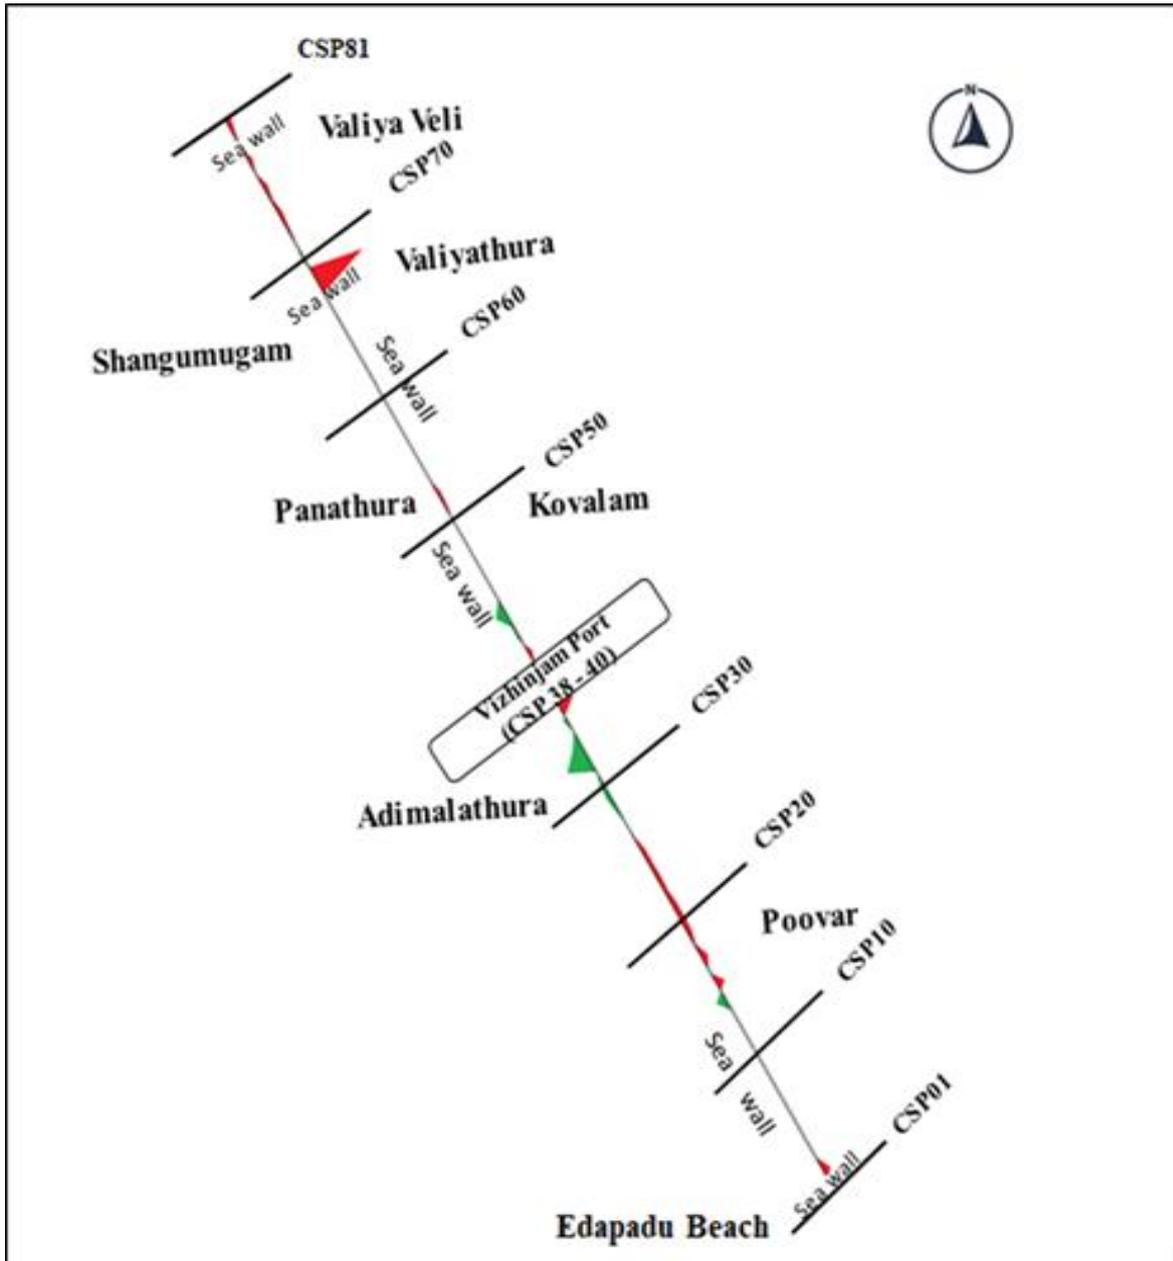
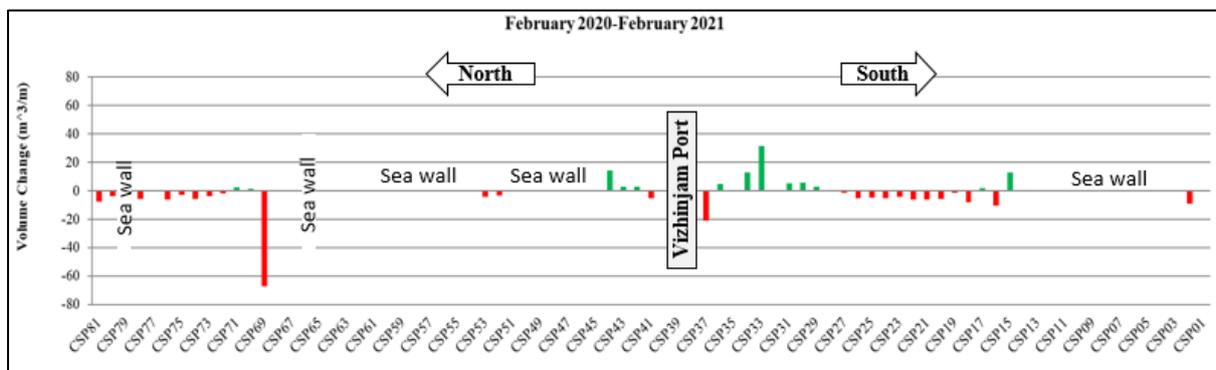
Figure 4.21 Beach Volume Changes during February 2020 and February 2021 in m³/m (onshore)

On the onshore part erosion noticed at Edapadu beach (CSP02), Poovar (CSP16), Poovar to Pulluvila (CSP18-28), Mullur (CSP37), Kovalam (CSP41), Pannathura to Punthura (CSP51-53), Shangumugham (CSP69), Vettucaud to Valiyaveli (CSP72-78) and Thumba (CSP80-81). Accretion found at Poovar (CSP15 and CSP17), Pulluvila to Adimalathura (CSP29-31), Adimalathura (CSP33-34), Mullur (CSP36) Kovalam (CSP42-44), Valliyathura (CSP66), and Shangumugham (CSP70-71).

The locations Edapadu beach (CSP02), Karumkulam (CSP22-25), Pulluvila (CSP27-28), Mullur (CSP37), Kovalam (CSP 41), Pannathura to Punthura (CSP51-53), Vettucaud (CSP73), Kochuveli (CSP73), Kochuveli (CSP75), Kochuveli to Valiyaveli (CSP77-78), Thumba (CSP81) eroded on onshore and offshore.

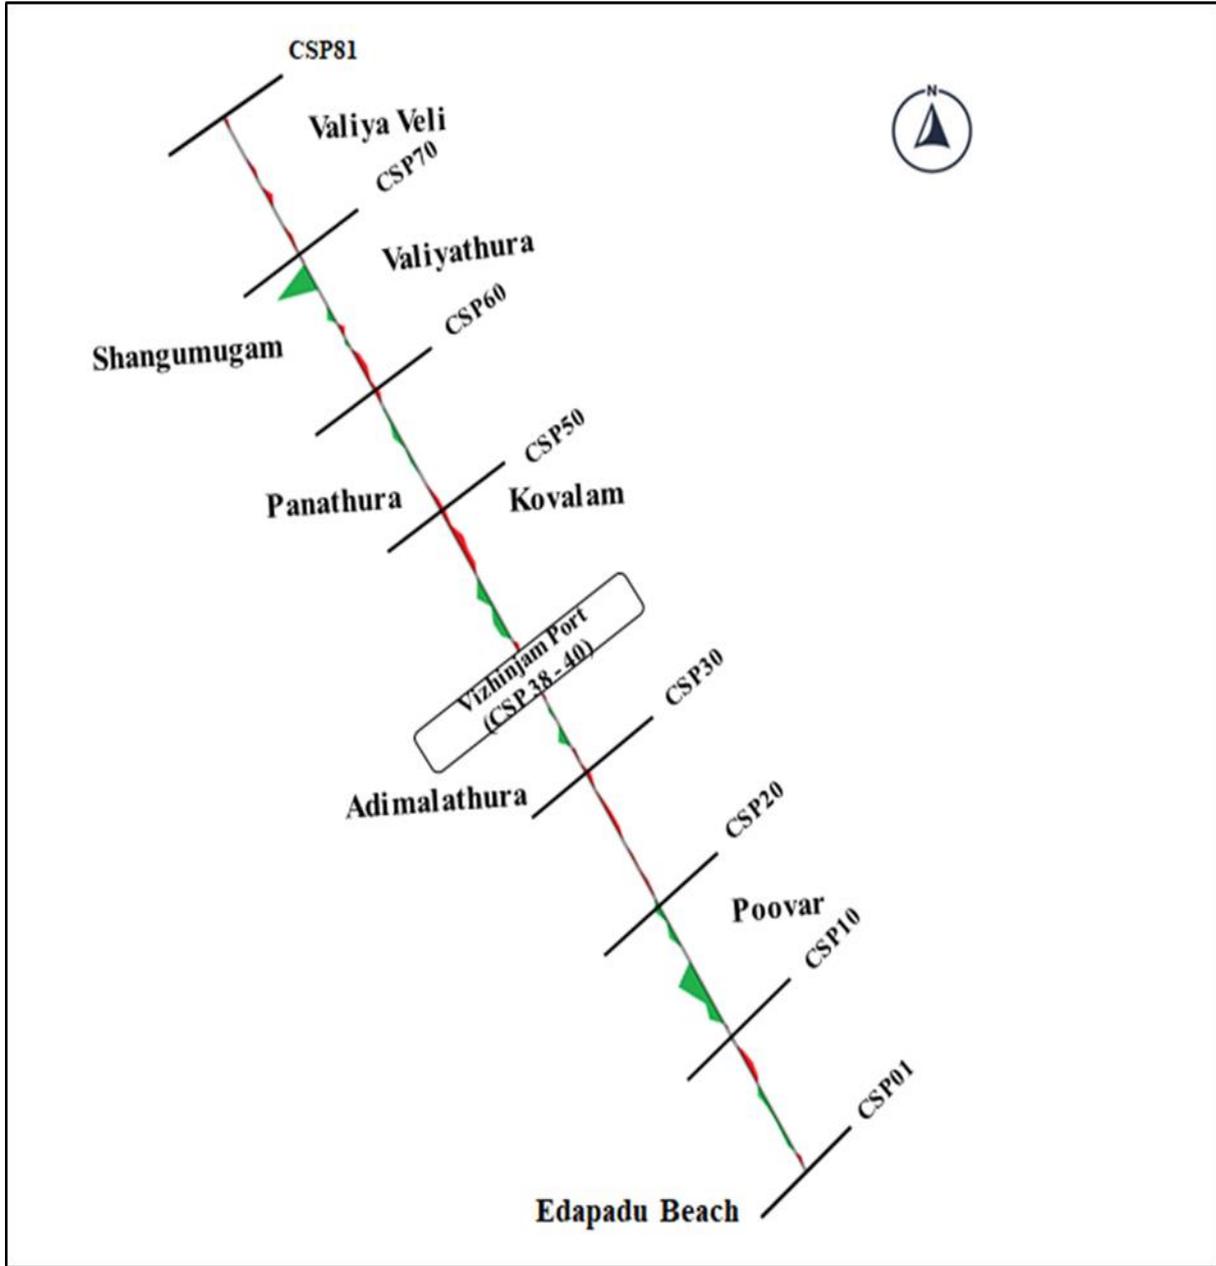
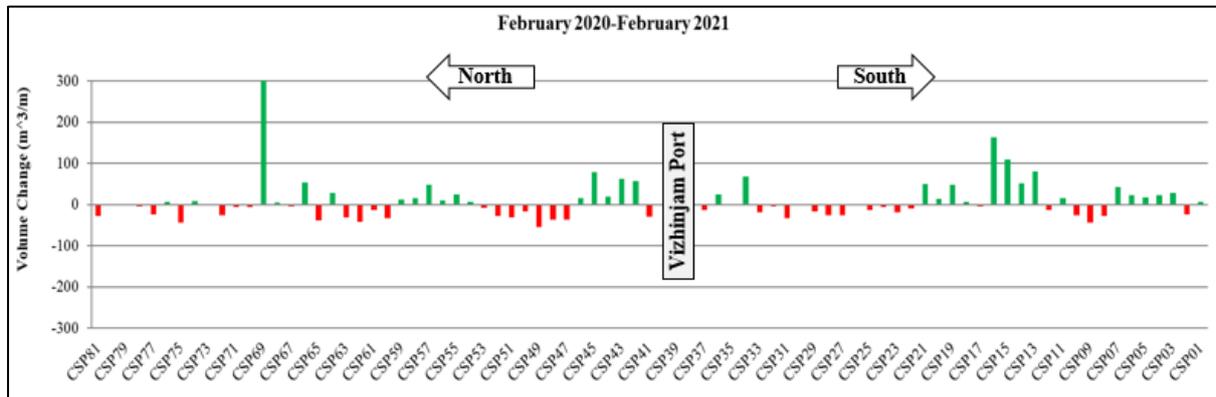
Figure 4.22 Beach Volume Changes during February 2020 and February 2021 in m³/m (offshore)

On the offshore erosion taken place at Edapadu beach (CSP02), Neerody to Pozhiyur (CSP08-10), Pozhiyur (CSP12), Poovar (CSP17), Karumkulam (CSP22-25), Pulluvila to Adimalathura (CSP27-33), Mullur (CSP37), Kovalam (CSP 41), Pannathura to Punthura (CSP47-53), Beemapally to Valliyathura (CSP60-63), Valliyathura (CSP65 and CSP67), Shangumugham to Vettucaud (CSP70-73), Kochuveli (CSP75), Kochuveli to Valiyaveli (CSP77-78), Thumba (CSP81). Accretion found at Edapadu Beach (CSP01), Edapadu to Neerody (CSP03-07), Pozhiyur (CSP11), Paruthiyoor to Poovar (CSP13-16), Poovar (CSP18-21), Karumkulam (CSP26), Adimalathura (CSP34), Mullur (CSP36), Kovalam (CSP42-46), Punthura to Beemapally (CSP54- 59), Valliyathura (CSP64 and 66), Shangumugham (CSP68-69), Vettucaud (CSP74), Kochuveli (CSP76), Thumba (CSP80).

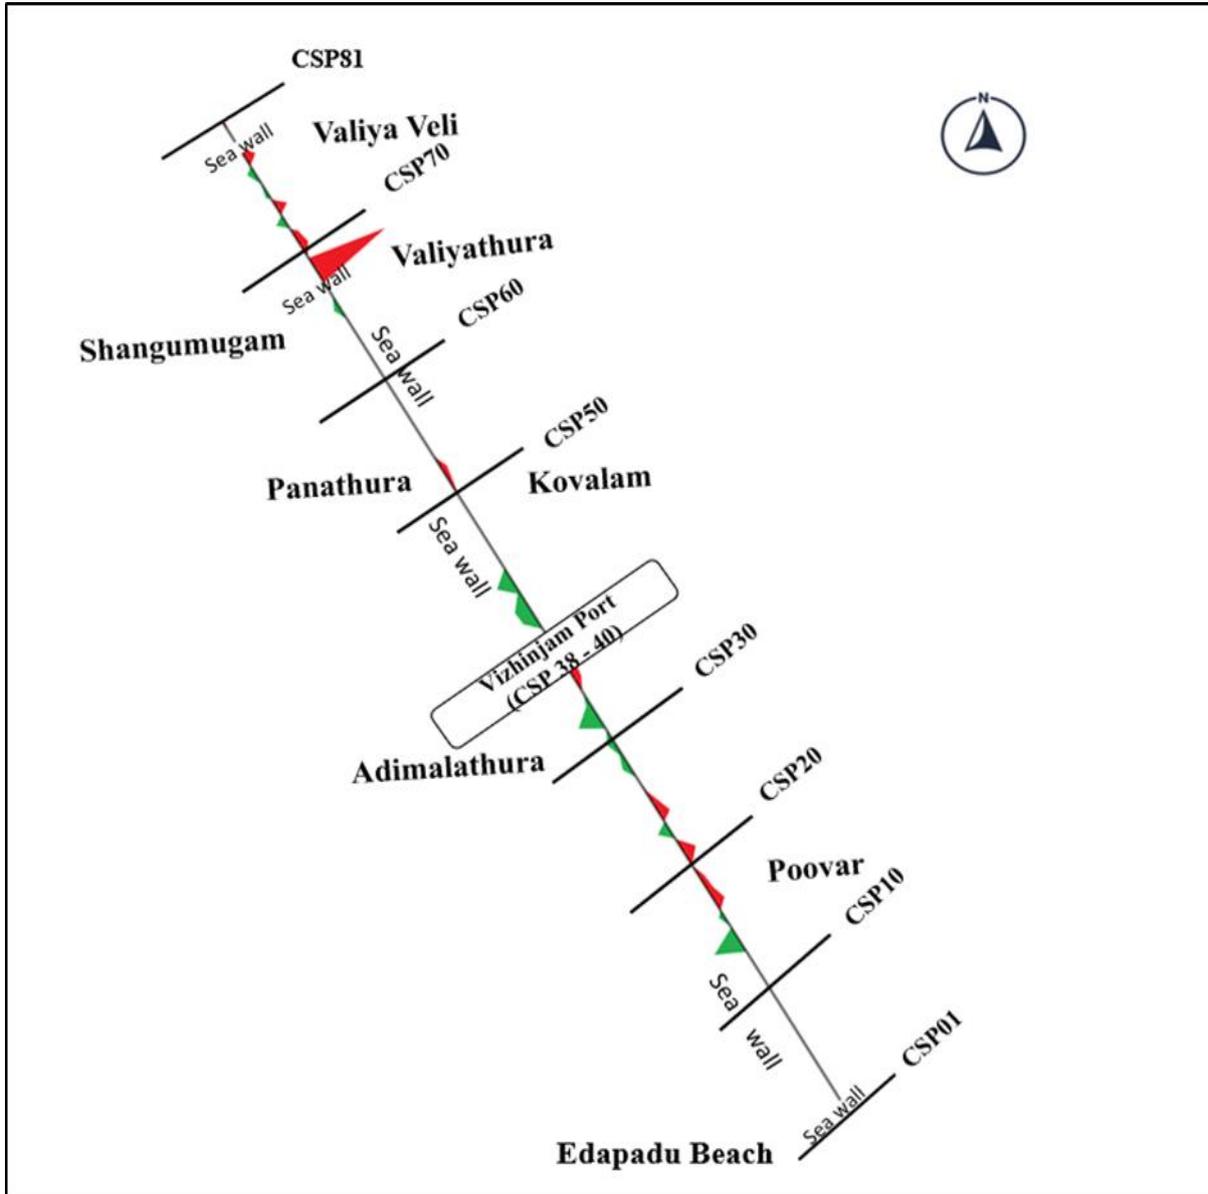
Figure 4.23 Beach Volume Changes during April 2020 and April 2021 in m^3/m (onshore)

CSP32 (no onshore data), CSP35 (no onshore data), CSP16 (April 2020 profile found erroneous), CSP02 (no data in April 2020) has not been included for the analysis. In April 2021 erosion found at Poovar to Karumkulam (CSP18-23), Karumkulam to Pulluvila (CSP25-27), Mullur (CSP36-37), Pannathura (CSP51-53), Shangumugham (CSP69), Shangumugham to Vettucaud (CSP71-72), Vettucaud (CSP74), Valiyaveli (CSP78) and Thumba (CSP81) compared to April 2020. Accretion found to have at Poovar (CSP15 and 17), Karumkulam (CSP24), Pulluvila to Adimalathura (CSP29-31), Adimalathura (CSP33-34), Kovalam (CSP41-44), Valliyathura (CSP66), Shangumugham (CSP70), Vettucaud (CSP73), Kochuveli (CSP75-77) and Thumba (CSP80).

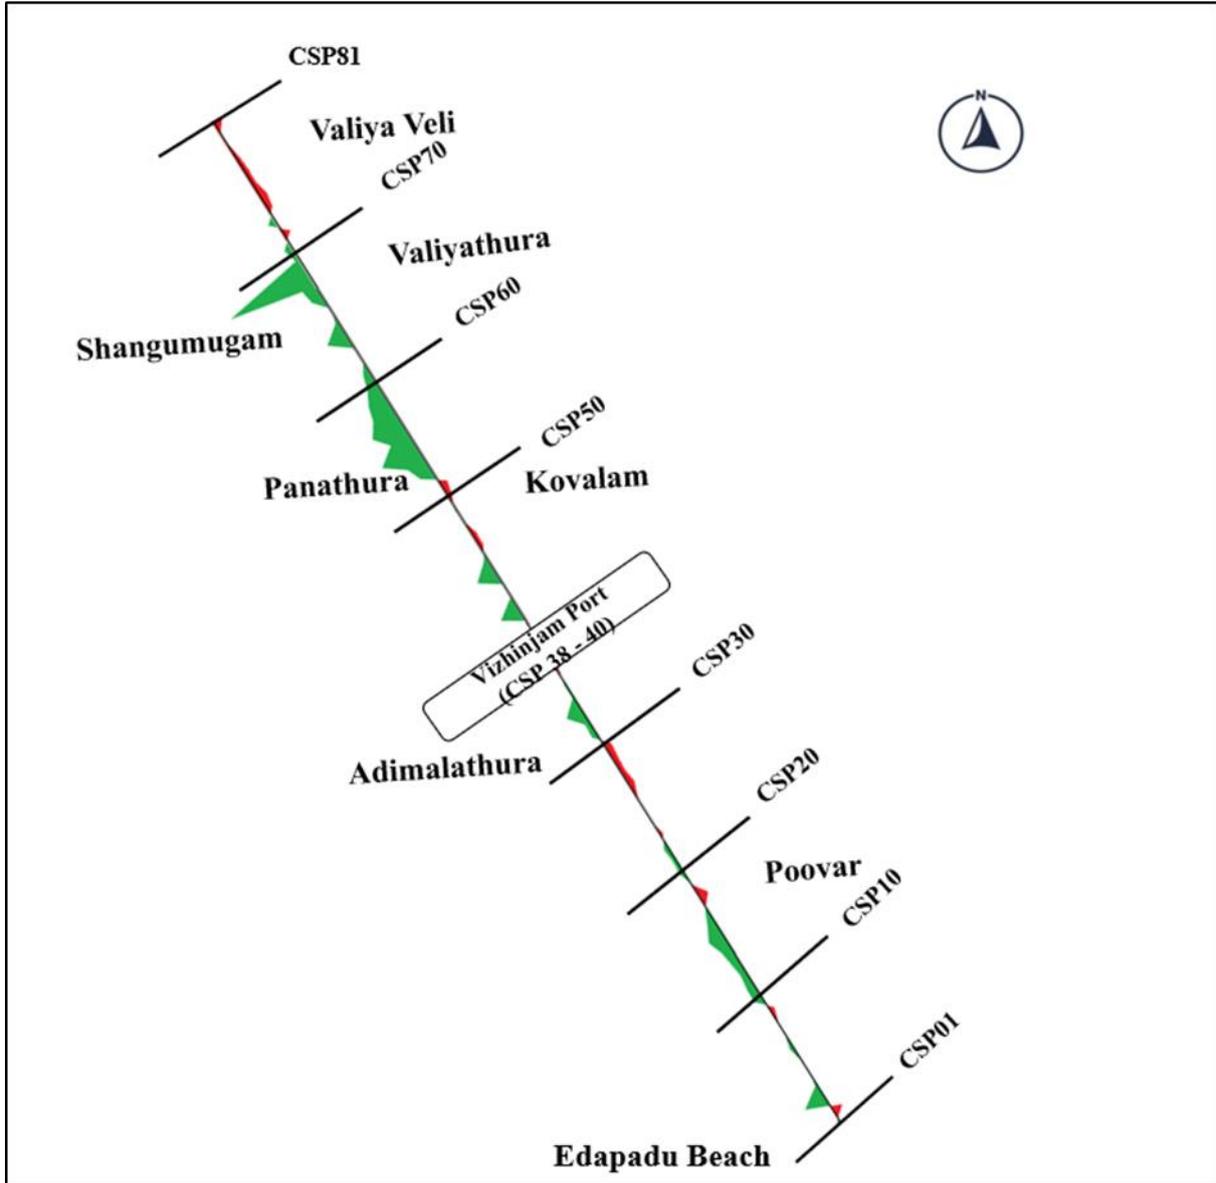
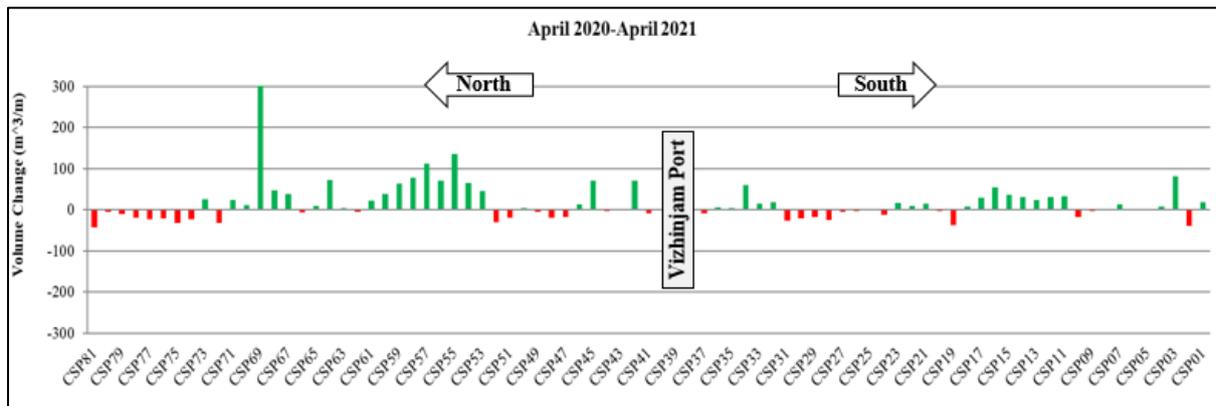
Figure 4.24 Beach Volume Changes during April 2020 and April 2021 in m³/m (offshore)

At Poovar (CSP19-20), Karumkulam to Pulluvila (CSP25-27), Mullur (CSP37), Pannathura (CSP51-52), Vettucaud (CSP72 and 74), Valiyaveli (CSP78) and Thumba (CSP81) erosion occurred on both sides of the cross shore line in April 2021 compared to April 2020.

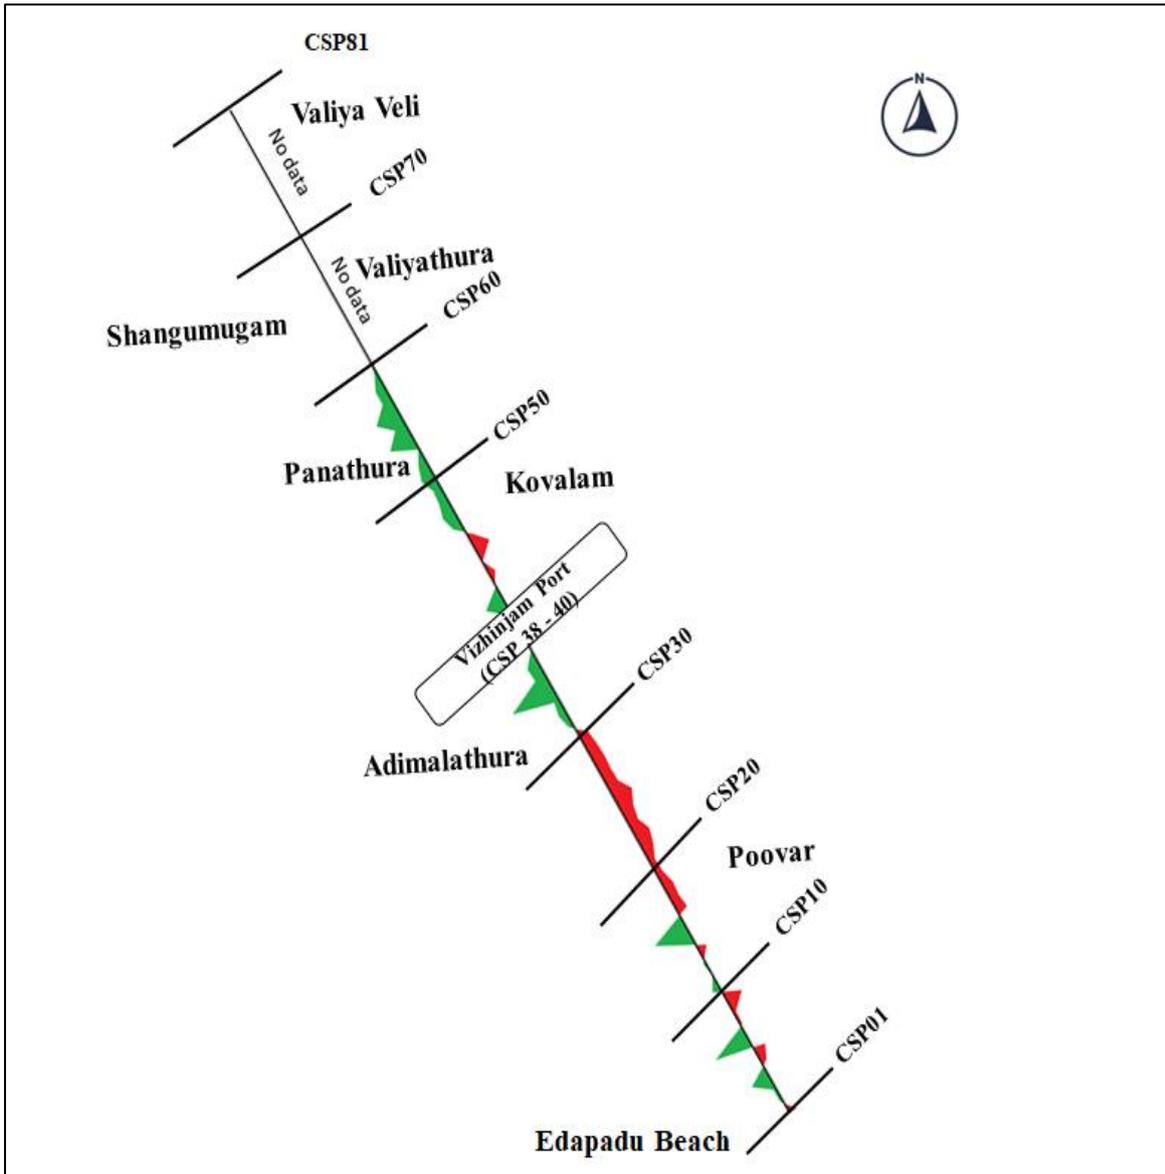
Figure 4.26 Beach Volume Changes during September 2020 and September 2021 in m³/m (offshore)

In September 2021 offshore data could not be collected from CSP62 to CSP81 due to Cyclone Gulab. On offshore part accretion was found at locations Edapadu to Vallavilay (CSP02-04), Neerody (CSP07), Pozhiyur to Paruthiyoor (CSP11-13), Poovar (CSP15-16), Adimalathura to Mullur (CSP32-37), Kovalam (CSP41-43), and Pannathura to Beemapally (CSP48-60). Erosion found at locations Edapadu (CSP01), Vallavilay (CSP05-06), Neerody to Pozhiyur (CSP08-10), Paruthiyoor (CSP14), Poovar to Adimalathura (CSP17-31), Kovalam to Kovalam North (CSP44-47) in September 2021 compared to September 2020.

From Poovar to Pulluvila (CSP18-28) the beach shows erosion on both sides of the cross shore line.

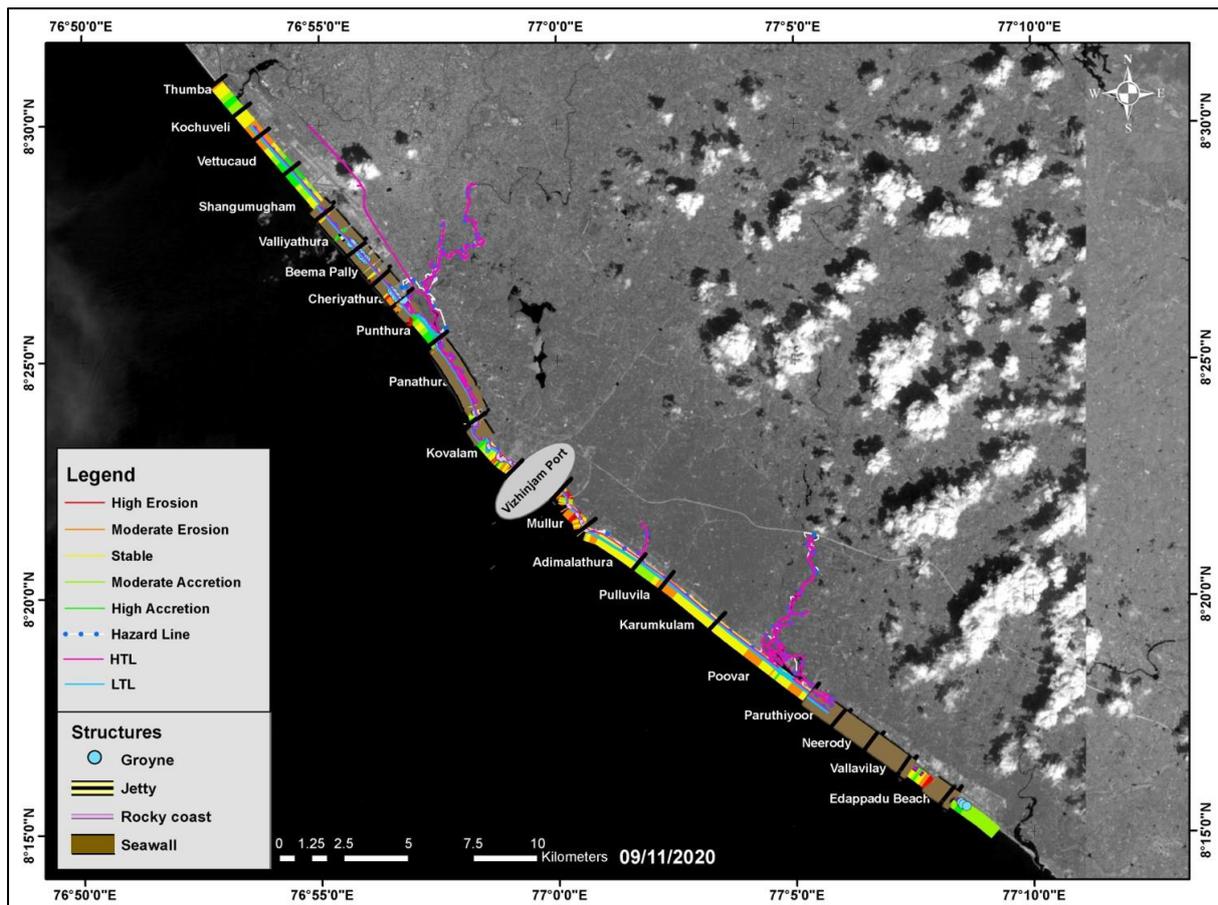
Figure 4.41 Shoreline Change Map –Post Monsoon 2020

The seasonal shoreline change analysis for the post monsoon period 2019 is shown in Figure 4.41. The shoreline change analysis map shows accretion at most of the locations while erosion noted at few sectors of Vettucaud (200m), Mullur (150m), Karumkulam (300m), Poovar (500m) and Edapadu beach (120m) for the post monsoon period (October 2020 to November 2020).

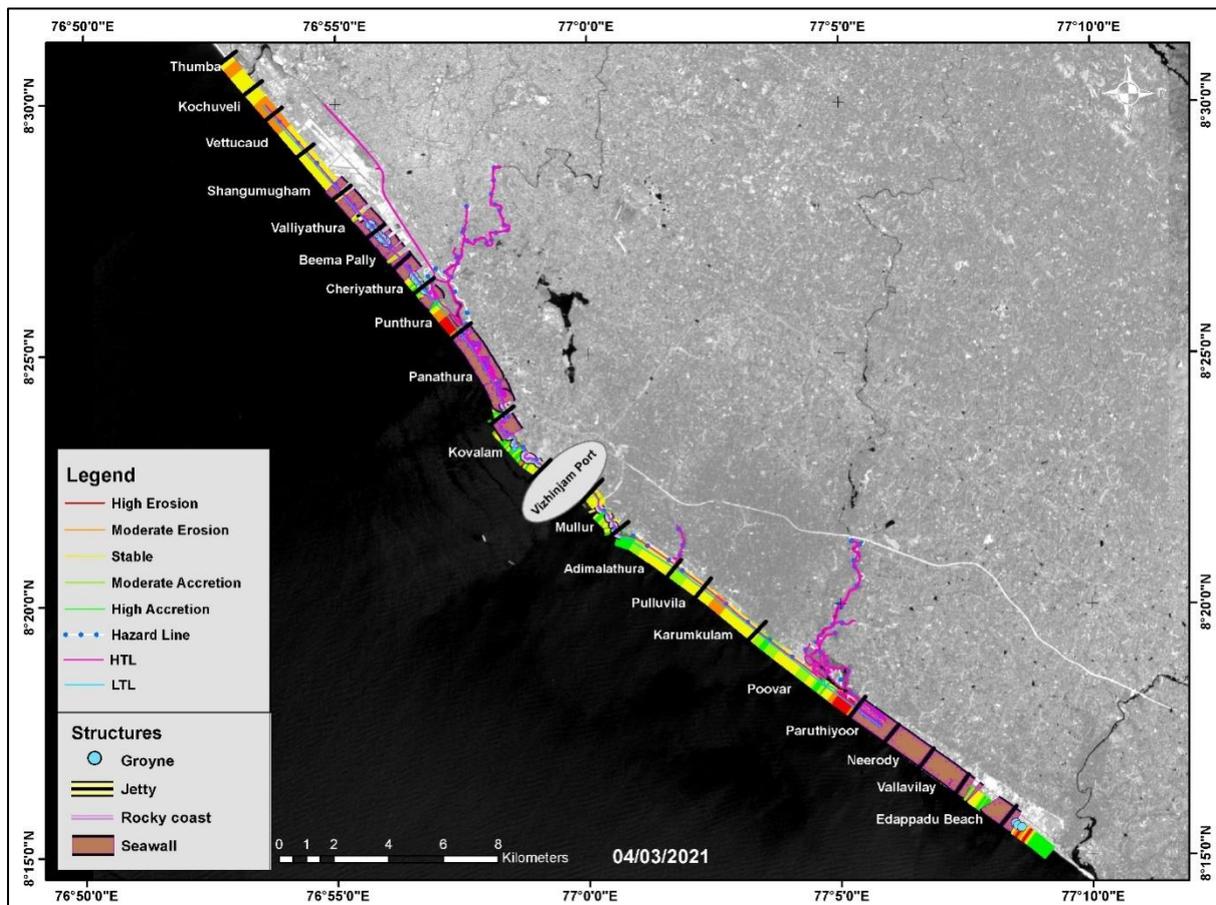
Figure 4.42 Shoreline Change Map –Fair Weather Period 2021

The seasonal shoreline change analysis for the fair weather period 2021 is shown in Figure 4.42. The fair weather period (December 2020 to March 2021) indicates stable at most of the locations while erosion is noticed at Punthura (600m) and Poovar (630m) and accretion at Kovalam (860m), Mullur (150m), Adimalathura (950m), Pulluvila(600m) and Poovar (1.4km).

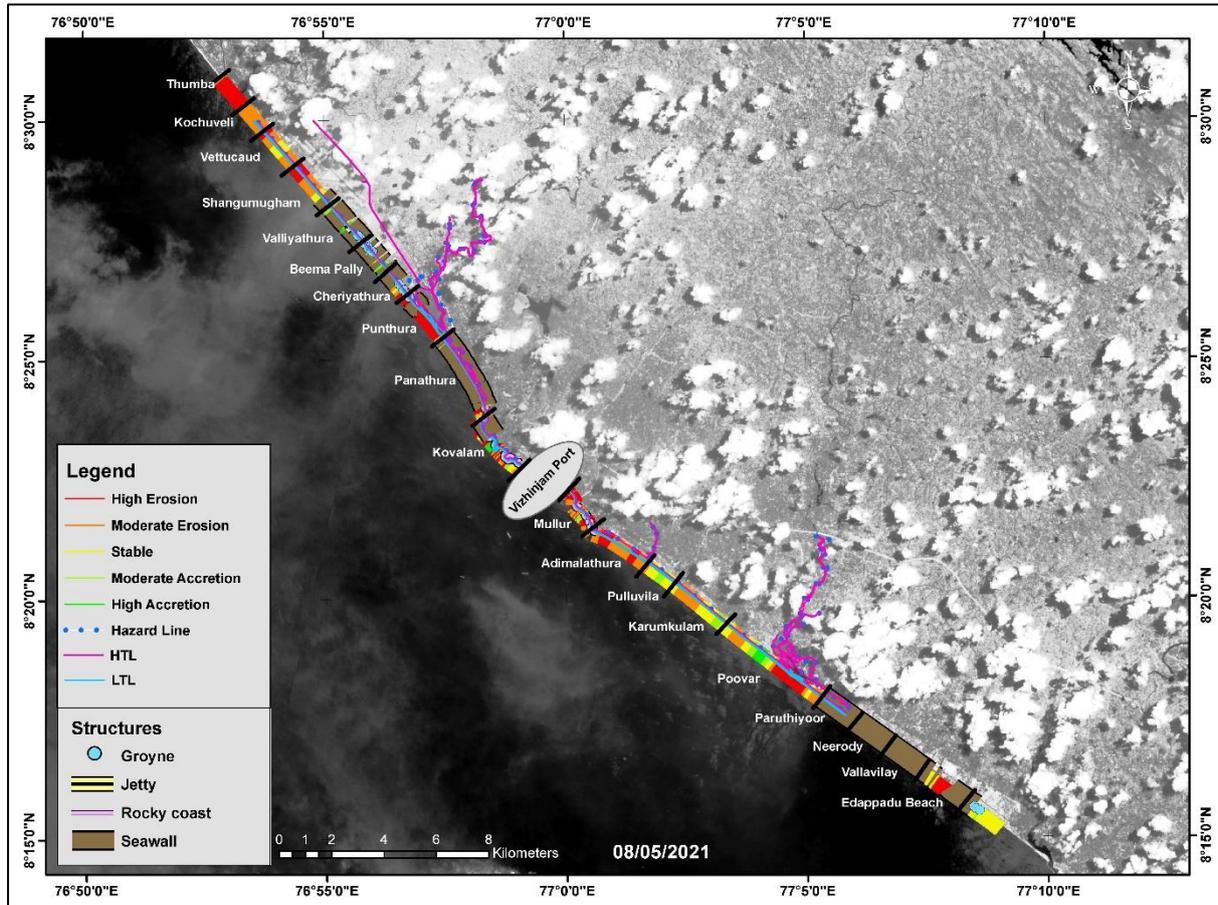
Figure 4.43 Shoreline Change Map –Pre-Monsoon Period 2021

The seasonal shoreline change analysis for the pre-monsoon period 2021 is shown in Figure 4.43. The pre-monsoon period (April 2021 to May 2021) indicates accretion at Karumkulam (360m) and Poovar (900m) while erosion noted at Thumba (1.5km), Vettucaud (250m), Shangumugham (700m), Punthura (1.25km), Mullur (670m), Adimalathura (700m), Poovar (1.5km) and Edapadu beach (500m).

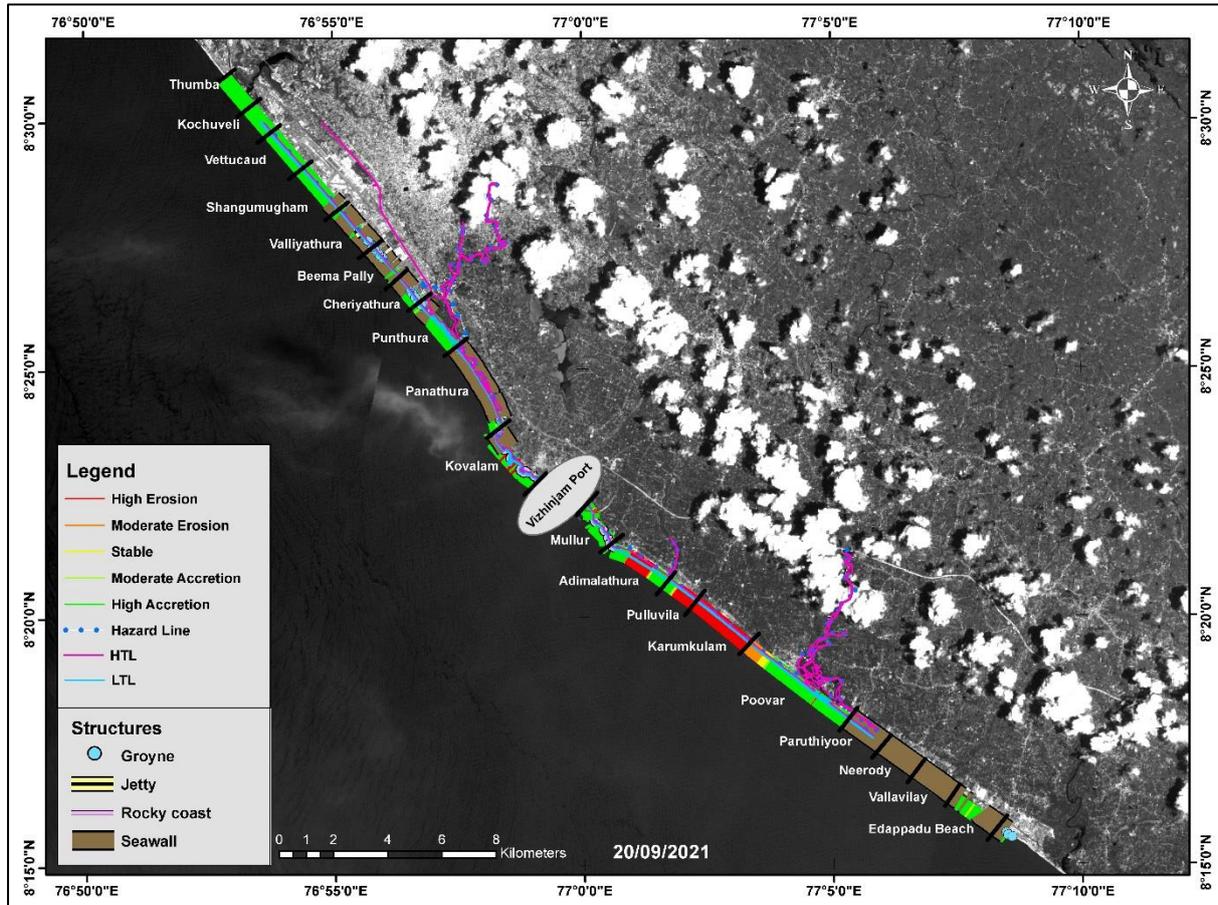
Figure 4.44 Shoreline Change Map – Monsoon Period 2021

The seasonal shoreline change analysis for the monsoon period 2021 is shown in Figure 4.44. During monsoon period (June 2021 to September 2021) erosion is noticed along Adimalathura (900m), Pulluvila (720m), Karumkulam (2.5km) and Poovar (700m) and accretion from Thumba to Mullur, Poovar and Edappadu beach.

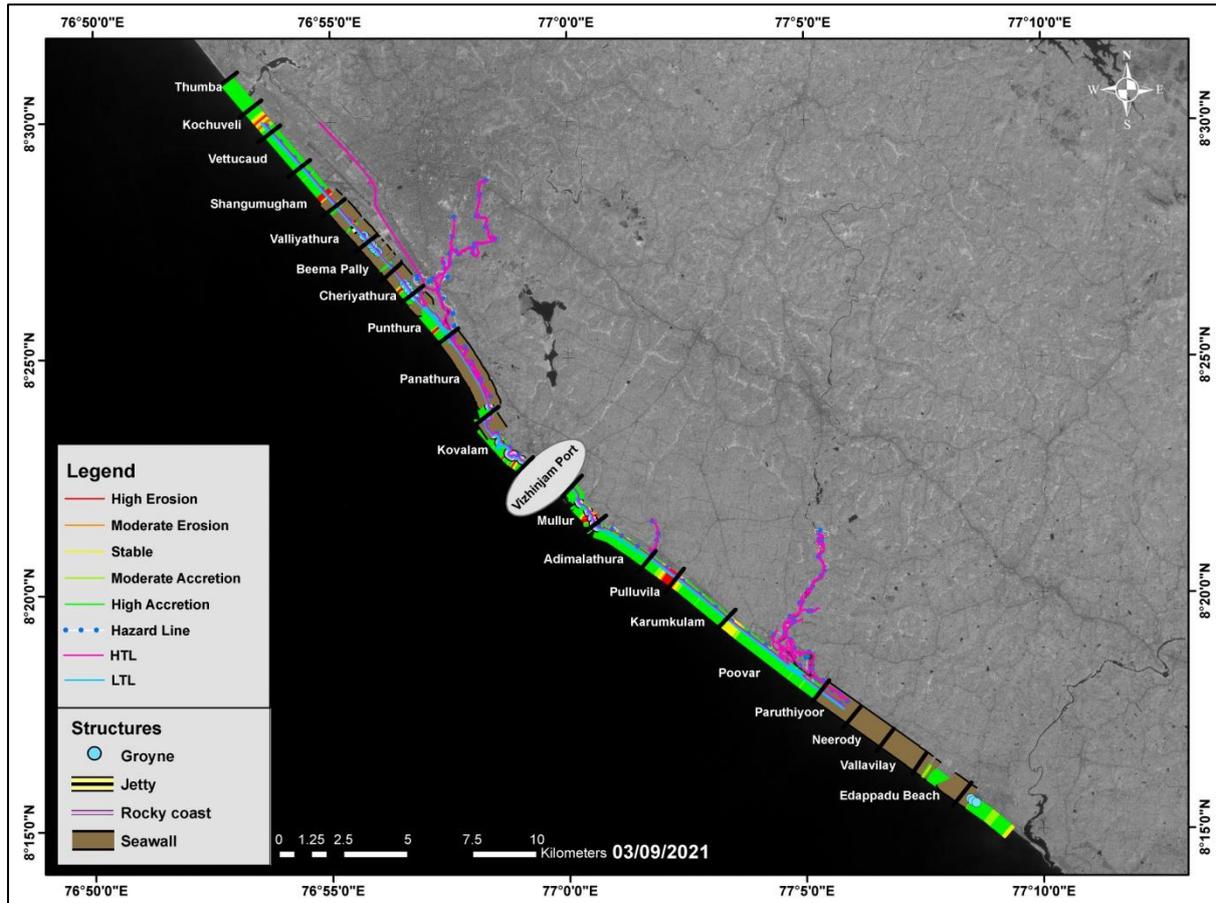
Figure 4.45 Overall Shoreline Change Map October 2020 to September 2021

Using high resolution satellite images (1m, 5m and 10m spatial resolution), the result has been processed for the period October 2020 to September 2021. Figure 4.45 shows the shoreline change map from October 2020 to September 2021. Erosion is noticed at Kochuveli (250m), Shangumugham (100m), Valliyathura (50m), Cheriyaathura (120m), Punthura (150m), Mullur (290m), Pulluvila (500m) and accretion at Thumba, Vettucaud and Shangumugham, Punthura, Adimalathura, Karumkulam, Poovar and Edappadu beach.

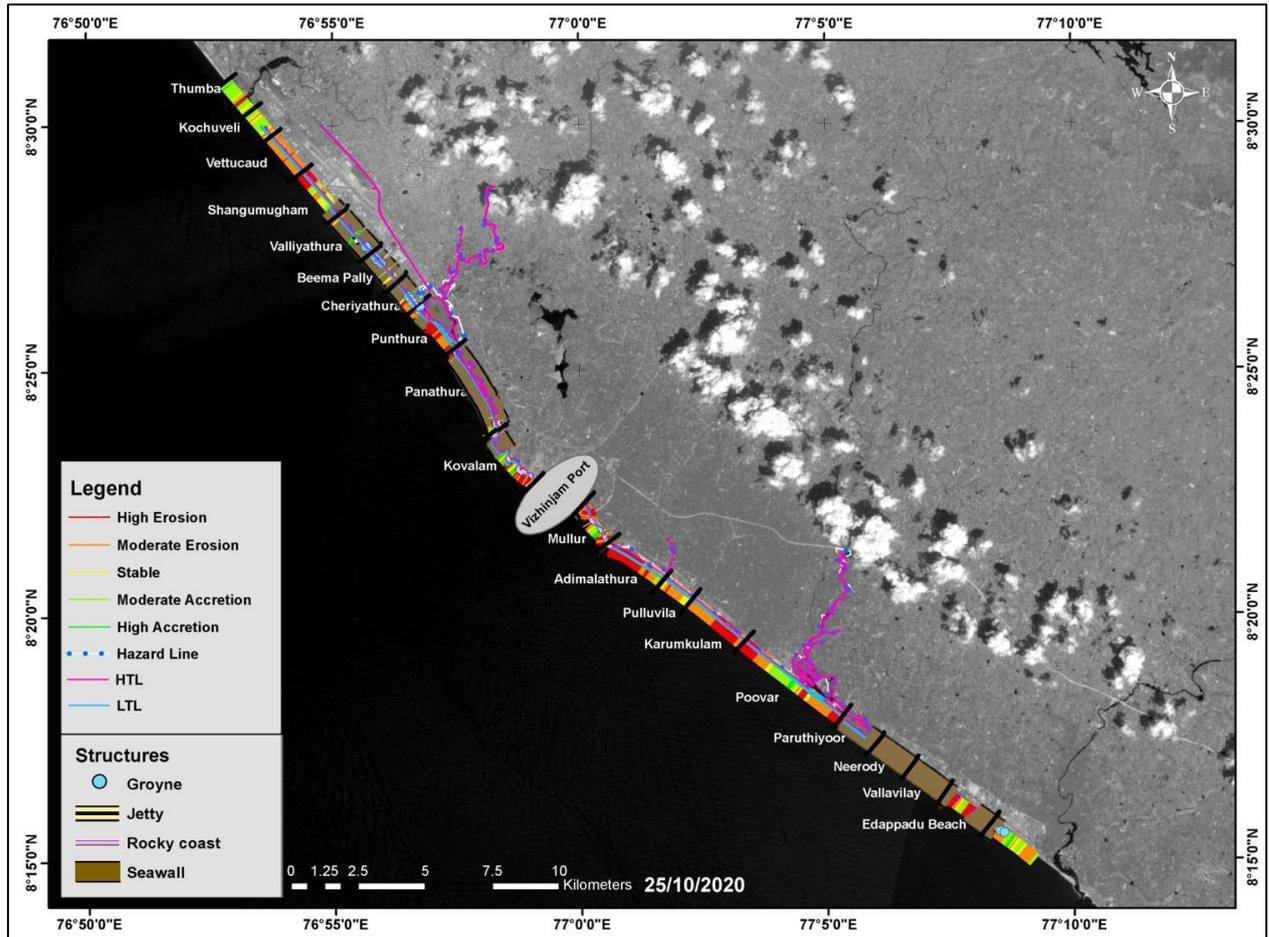
Figure 4.46 Shoreline Change Map October 2019 and October 2020

Using Resourcesat 2A-LISS4 and Sentinel 2A/2B-MSI satellite images (5m and 10m spatial resolution), the shoreline change has been compared between the October 2019 and October 2020 shorelines. Figure 4.46 shows the shoreline change map for October 2019 and October 2020. Accretion is noticed at Thumba, Kochuveli, Beemapally, Poovar, and Neerody and at few sectors of Beemapally, Kovalam, and Mullur while erosion is noticed at Vettucaud, Shangumugham beach, Valliyathura, Cheriyaathura, Punthura, Pannathura, Adimalathura to Karumkulam, Paruthiyoor, Vallavilay and Edappadu beach for the shoreline change comparison between October 2019 and October 2020.

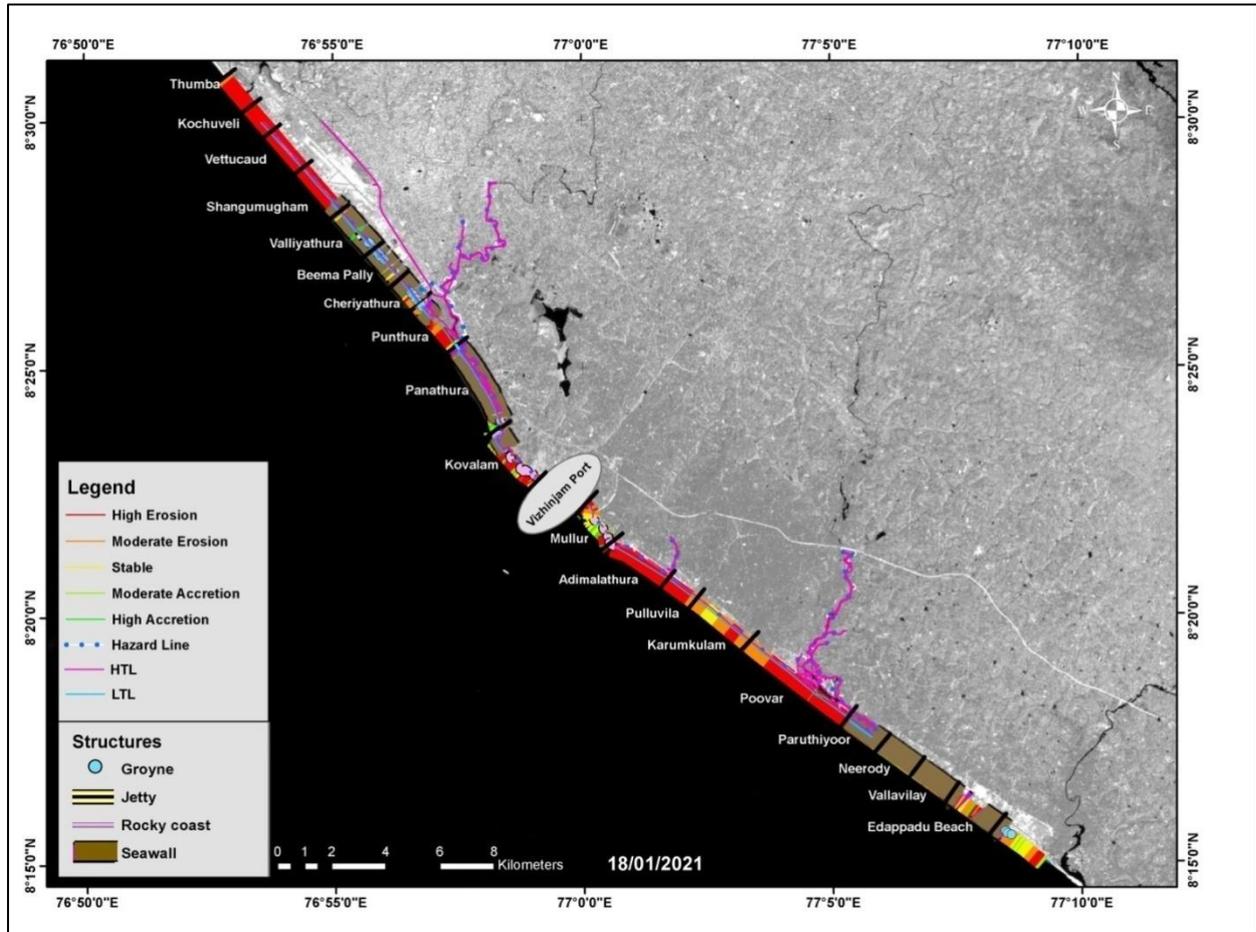
Figure 4.47 Shoreline Change Map February 2020 and February 2021

Using Resourcesat 2A-LISS4 and Sentinel 2A/2B-MSI satellite images (5m and 10m spatial resolution), the shoreline change has been compared between the February 2020 and February 2021 shorelines. Figure 4.47 shows the shoreline change map for February 2020 and February 2021. Accretion is noticed at Thumba, Kochuveli, Beemapally, Poovar, Neerody and at few sectors of Beemapally, Kovalam, and Mullur while erosion is noticed at Vettucaud, Shangumugham beach, Valliyathura, Cheriyaathura, Punthura, Panathura, Adimalathura to Karumkulam, Poovar, Paruthiyoor, Vallavilay and Edapadu beach for the shoreline change comparison between February 2020 and February 2021.

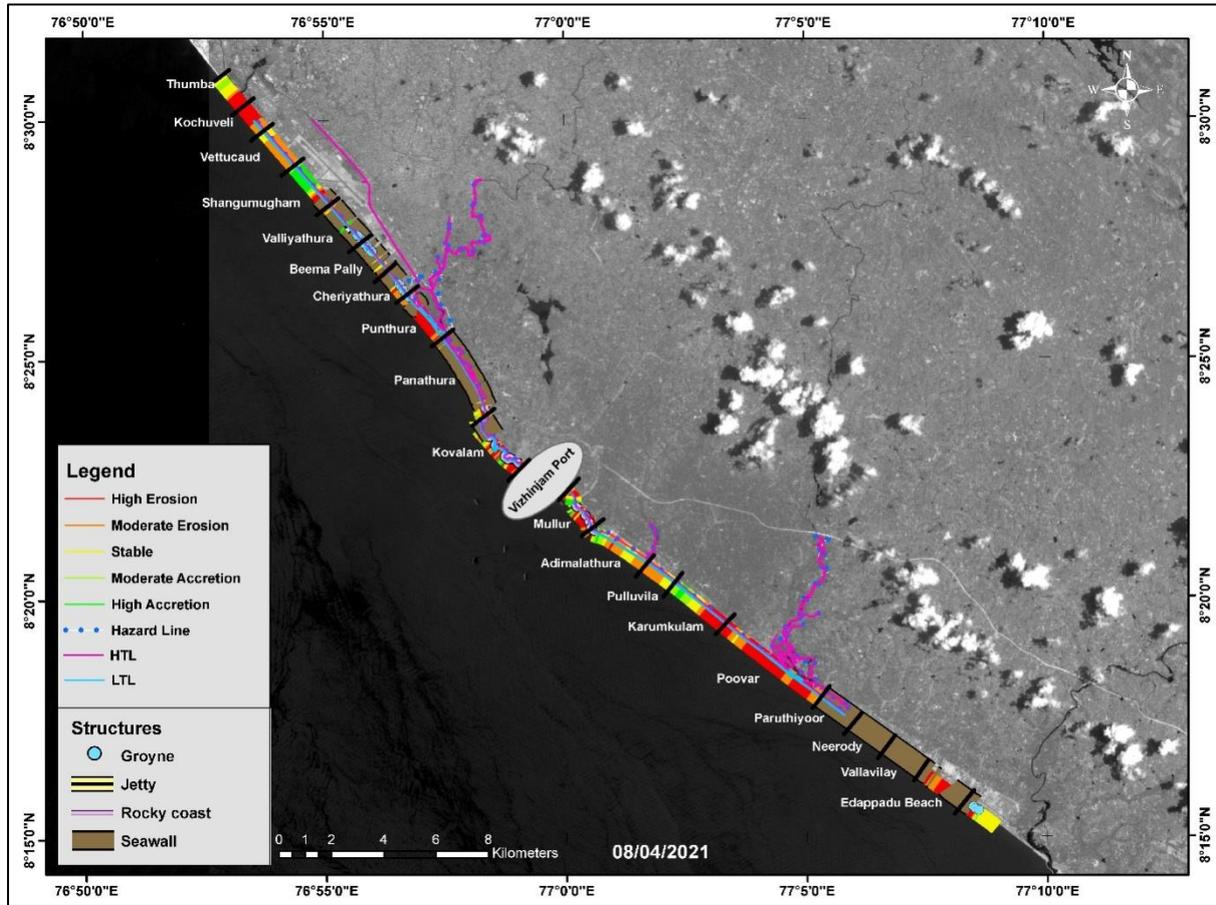
Figure 4.48 Shoreline Change Map April 2020 and April 2021

The shoreline change has been compared between the April 2020 and April 2021 shorelines using Sentinel 2A/2B-MSI satellite images (10m spatial resolution). Figure 4.48 shows the shoreline change map for April 2020 and April 2021. Accretion is noticed at Shangumugham beach, few sectors of Mullur, Adimalathura, northern sectors of Karumkulam while erosion is noticed at Kochuveli, Valliyathura, Punthura, southern sectors of Karumkulam, Poovar and Edapadu beach for the comparison of shorelines between April 2020 and April 2021.

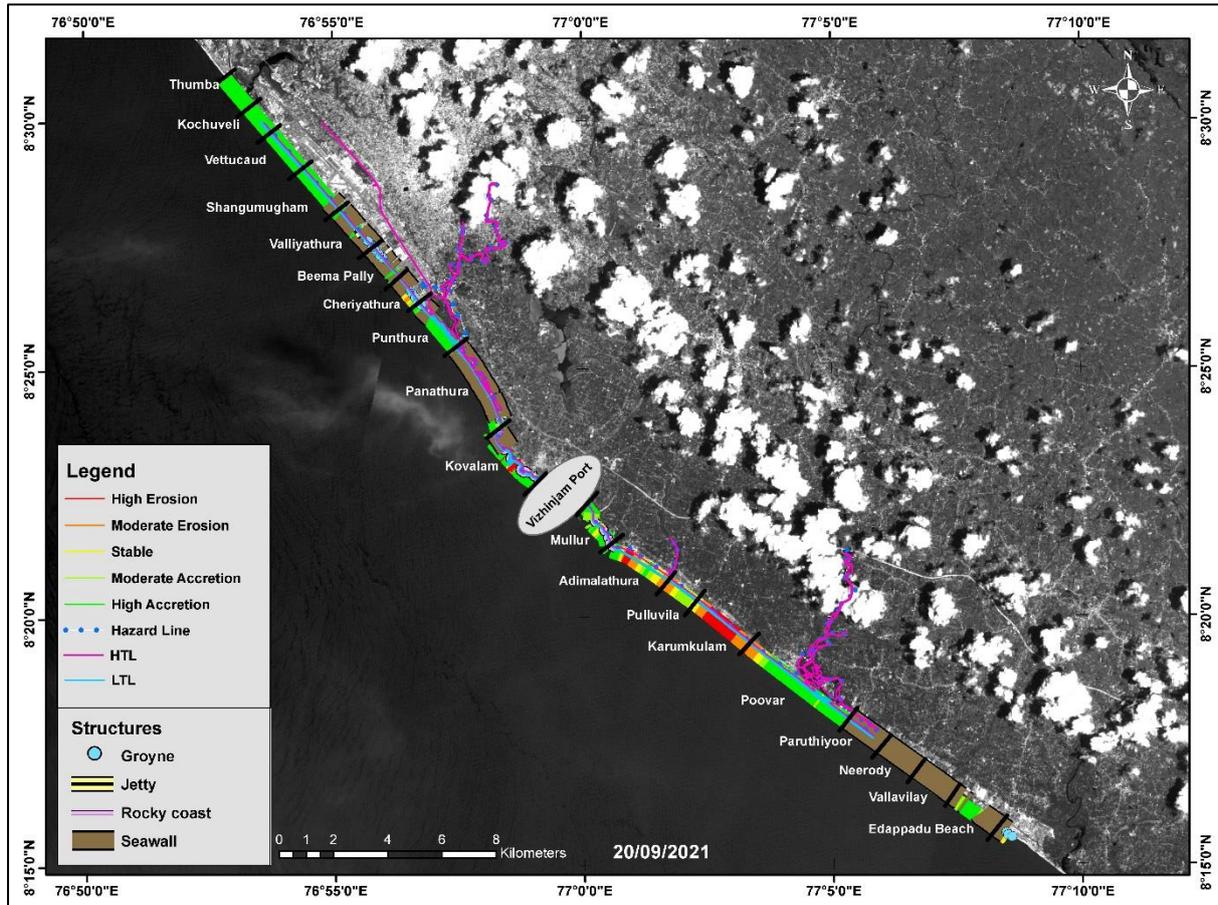
Figure 4.49 Shoreline Change Map September 2019 and September 2020

The comparison of shorelines of September 2020 with September 2021 is shown in Figure 4.49 and erosion is noted at Cheriyaathura (150m), Adimalathura (600m), Karumkulam (2km) and Poovar (380m).
