**SHORELINE CHANGE ANALYSIS OF VIZHINJAM COAST USING
BEACH PROFILES AND SATELLITE IMAGES**

**ANNUAL REPORT
(October 2020 to September 2021)**

ADANI VIZHINJAM PORT PVT LIMITED

**Coastal and Environmental Engineering Division
NATIONAL INSTITUTE OF OCEAN TECHNOLOGY
CHENNAI
June, 2022**

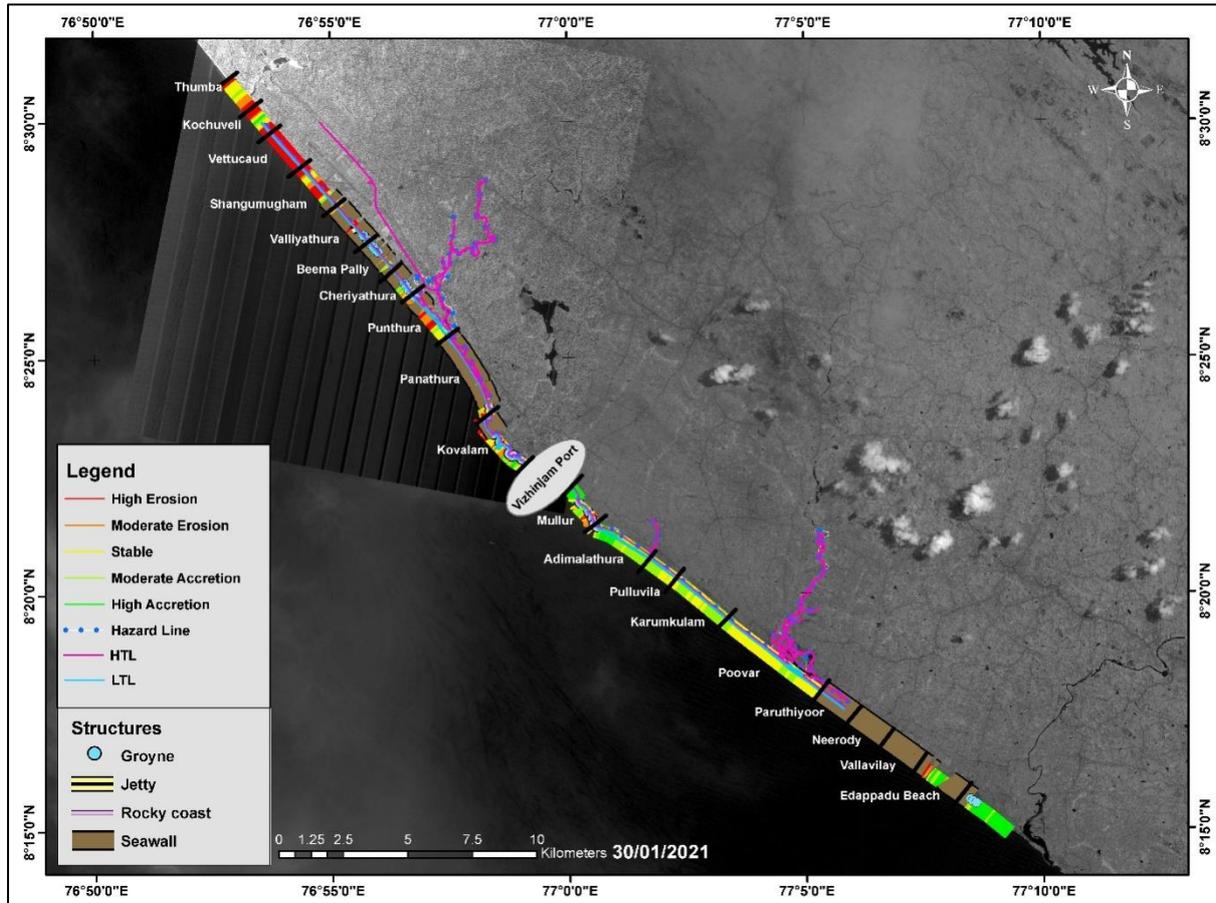
Figure 4.50 Shoreline Change Map- January 2015 to January 2021

The comparison of January 2015 shoreline with January 2021 using high resolution satellite images has been presented in the Figure 4.50. The comparison shows erosion at Thumba to Shangumugham beach, Punthura while Mullur and Edapadu beach shows accretion and stable at Poovar.

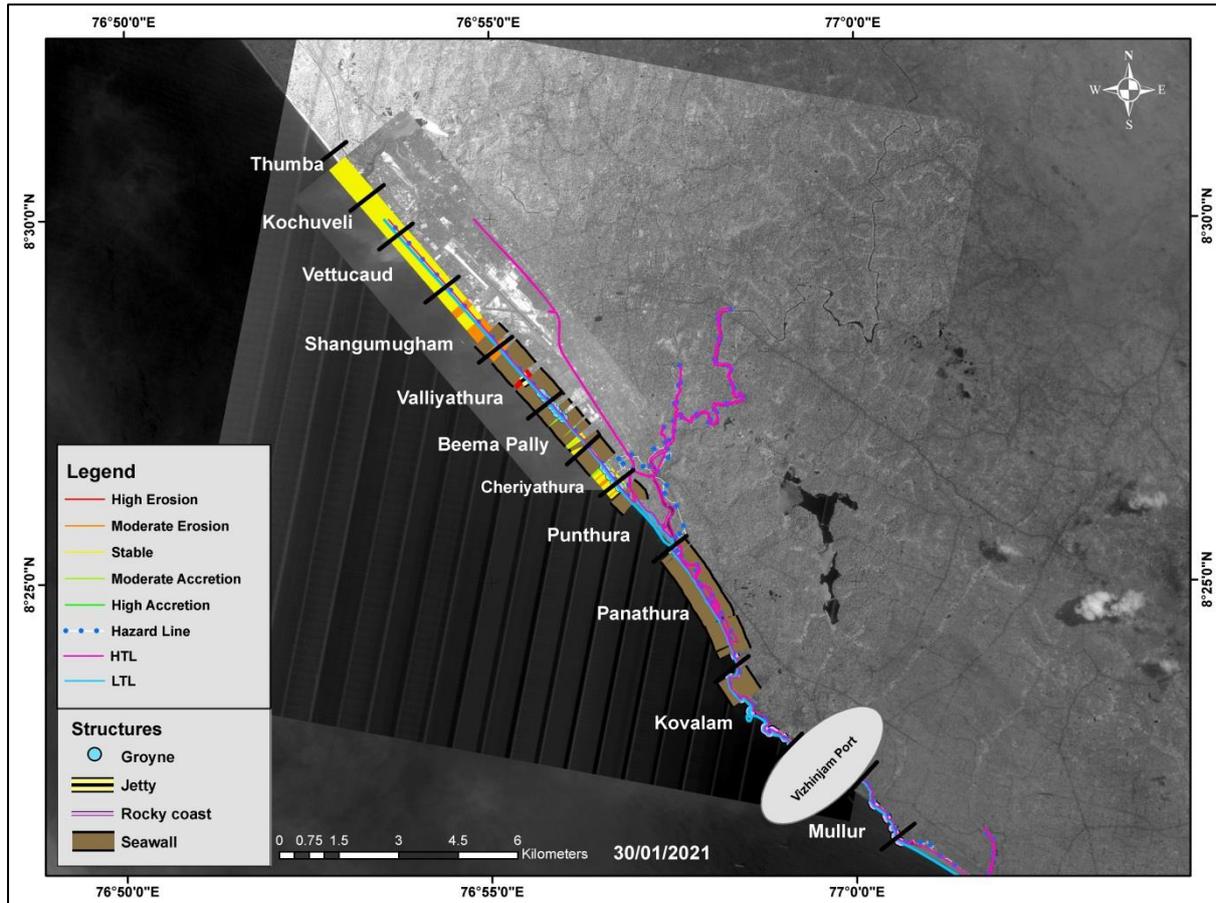
Figure 4.51 Shoreline Change Comparison- February 2011vsJanuary 2021

The shoreline change comparison of February 2011 with January 2021 has been carried out using high resolution images of 1m spatial resolution covering north of Vizhinjam Port (as available and procured from NRSC). The result from the analysis indicates erosion at Shangumugham (600m), Valliyathura (200m) and Cheriyaathura (100m) and Stable from Thumba o Vettucaud.

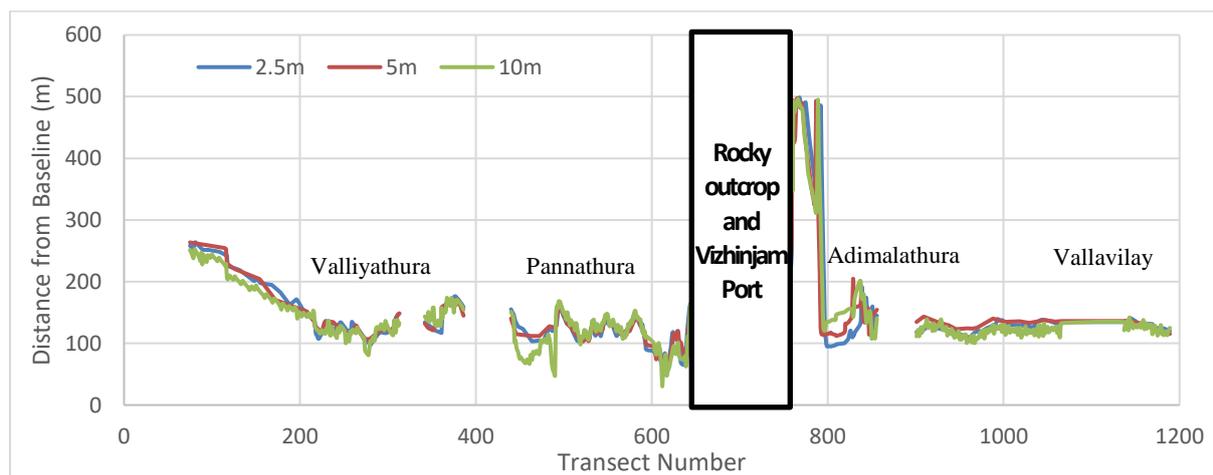
Figure 4.52 Comparison of Shoreline data from satellite images of different spatial resolution and beach profile data with field shoreline

As suggested in the shoreline committee dated 5th September 2019, the LTL, HTL and Hazard line has been demarcated on the shoreline maps provided in this report. Also, the graph shown in Figure 4.52 compares the shoreline derived from 5m and 10m satellite images, beach profile data, LTL, Hazard line with the field collected shoreline data specific to the stretch from Shangumugham to Punthura.

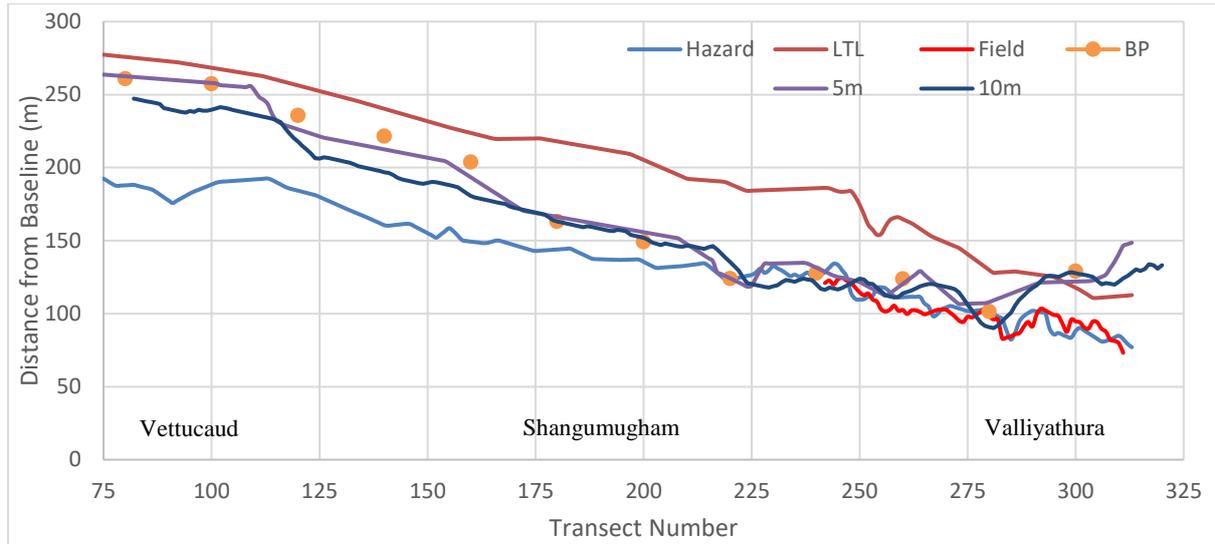
Figure 4.53 Comparison of Shoreline data from satellite images of different spatial resolution, beach profile data, LTL, Hazard line with field shoreline from Vettucaud to Valliyathura

A comparison of shorelines extracted from the satellite images of different spatial resolution has been shown in Figure 4.53. The difference error has been estimated for 10m and 5m satellite image compared with 1m satellite image. The average difference error for 10m satellite image when compared to 1m satellite image is 3.3m and the average difference error for 10m satellite image when compared to 5m satellite image is 2.9m while the average difference error for 5m satellite image when compared to 1m satellite image is 0.4m. However, due to non availability of higher resolution images (5m and 1m) for the monthly analysis, only 10m satellite images have been used and the available 5m and 1m satellite image has been incorporated in the analysis.
